A Material Evaluation of the Gropius House: Planning to Preserve a Modern Masterpiece

Author(s): Susan L. Buck

Source: *APT Bulletin*, Vol. 28, No. 4, Mending the Modern (1997), pp. 29-35

The American home of the renowned Bauhaus founder, tucked into the rural community of Lincoln, Massachusetts, is the subject of interior and exterior materials analysis.

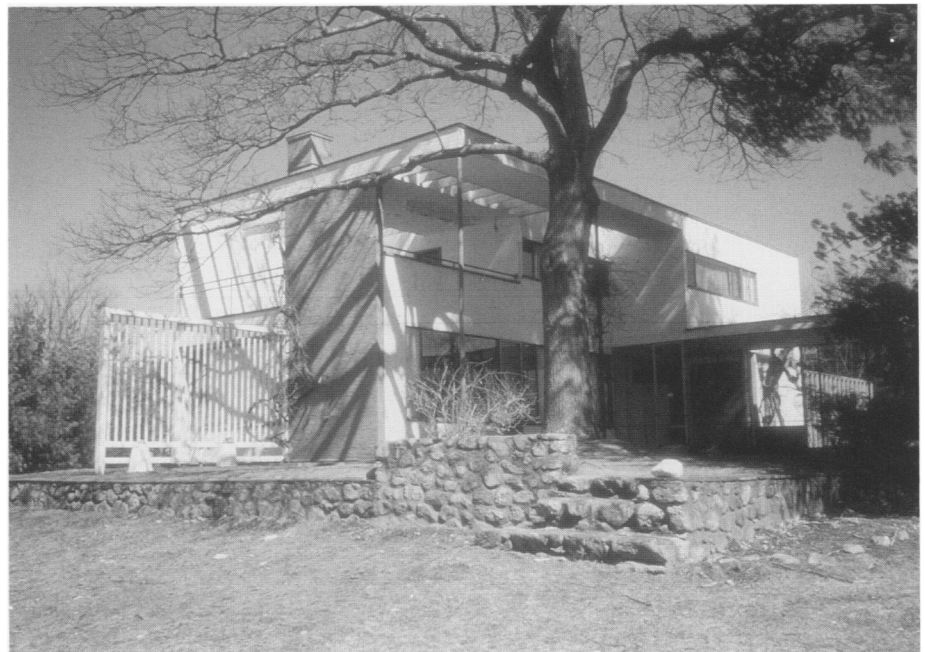
Fig. 3. The south and west facades of the Gropius House, with second-floor porch and pink sheathing. Photograph by Christopher A. Packard.

The first generation of pink paint on the porch sheathing is one of the few clearly datable layers (Fig. 3). It was applied in 1949 to reduce the bright reflection from the south-facing wall. Gropius explained the decision:

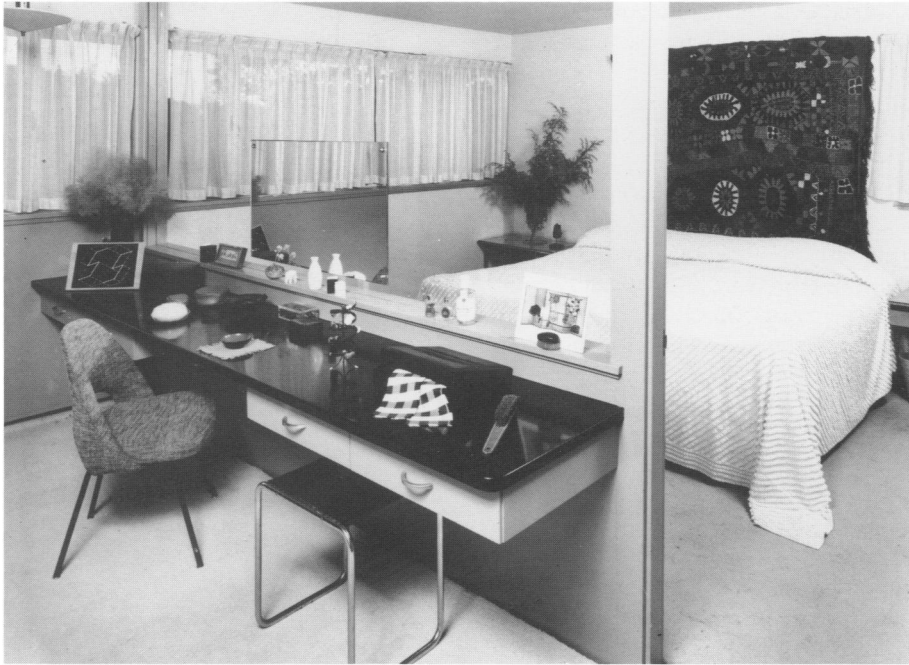
Fig. 4. The dressing room and master bedroom are separated by a large window wall. The other walls are covered with painted canvas. Photograph by J. David Bohl. Courtesy of the Society for the Preservation of New England Antiquities.

Inspection of the walls indicated that, with the exception of the glass dividing wall, many of the surfaces are covered with the same type of cotton canvas used in the entrance hall (Fig. 4). Paint analysis showed that the wallcovering was first painted deep red-brown, with a coarsely textured red-brown paint applied in three layers. The three layers vary slightly in color, perhaps because Gropius was trying several different shades until finally settling on the third red-brown. This red-brown paint has penetrated deeply into the fibers of the textile, suggesting this wallcovering was never left unpainted. In the second paint

generation both spaces were repainted with a thin, somewhat more finely ground, red-brown paint, and then the rooms were repainted light gray in the third and fourth paint generations.

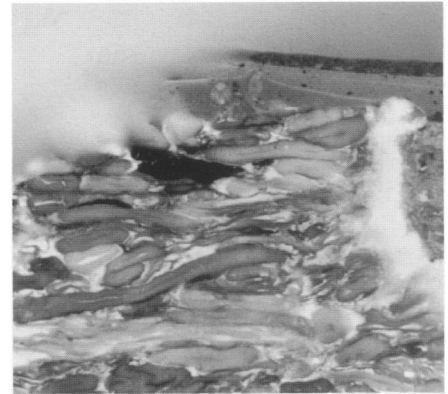
Fig. 5. A cross section of the black laminate on the dressing table shows a fibrous substrate and four black coatings. An autofluorescent resin component is visible in the substrate (photographed at 125X under ultraviolet light). Photograph by Susan L. Buck.

The worn edges of the dressing table reveal a coarse, fibrous substrate. The cross-section samples showed four opaque black layers applied to a fibrous substrate with a resinous binder (Fig. 5). Its laminated structure is similar to that of Formica, in which layers of resin-impregnated kraft paper are cured under heat and pressure.¹⁸ Despite wear, it is still remarkably glossy and quite striking in appearance.
