### Conservation techniques on the reinforced concrete pillars of the church of the San Carlo Borromeo hospital in Milan

# Conservation techniques on the reinforced concrete pillars of the church of the San Carlo Borromeo hospital in Milan

**ABSTRACT.** The reinforced concrete pillars of the Church of Santa Maria Annunciata at the San Carlo Borromeo hospital in Milan, designed by the architect Gio Ponti in the early Sixties, show signs of damage due to reinforcement corrosion. They require repair in order to remedy already present damage and also to prevent future propagation. The repair should also aim at preserving the integrity of the original materials, owing to the architectural and cultural value of the Church. The paper describes a trial work aimed at defining an appropriate procedure of restoration. Initially the pillars were inspected to assess their condition by means of non-destructive techniques and analyses on concrete samples. Then the effectiveness of two repair techniques, i.e. electrochemical realkalisation and hydrophobic treatment, was evaluated by comparison with non-treated areas.

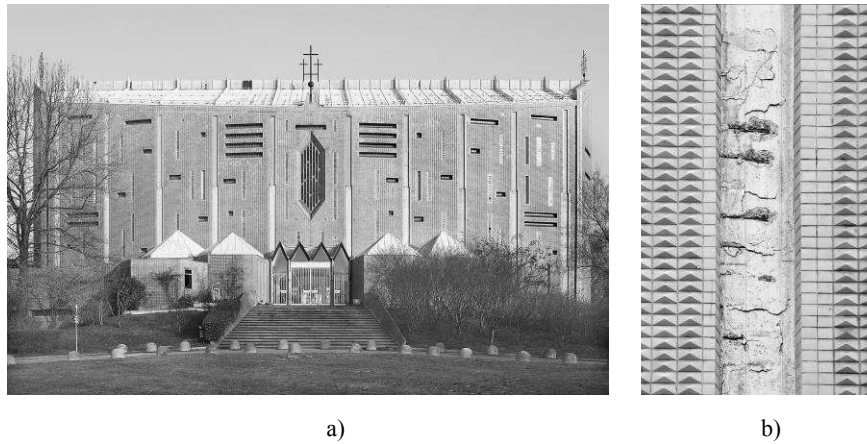
The degradation of the reinforced pillars is clearly due to the corrosion of the reinforcing bars, as it is shown by the presence of concrete loss and spalling of the concrete cover. Being the Church exposed to a urban environment, the corrosion is likely to be due to the carbonation of concrete, a natural process that causes the alkalinity of concrete, which is initially very high, to reduce and approach neutrality. Steel rebars are protected from corrosion as long as they are in contact with alkaline concrete, while they can corrode after concrete carbonation. So, when concrete carbonation reaches the depth of the rebar, *i.e.* the whole concrete cover is carbonated, corrosion initiates. The rate of corrosion is mainly determined by the availability of water and oxygen in the concrete, and is therefore influenced by the exposure conditions of the concrete element. The corrosion of the embedded steel damages the concrete by causing initially the formation of cracks and then by spalling and swelling the concrete cover. The time necessary for the concrete to be damaged is the sum of the initiation period (*i.e.* the time necessary for the carbonation to reach the rebars), which depends on the carbonation rate and on the thickness of the concrete cover, and of the propagation period (*i.e.* the time necessary for the corrosion products to damage the concrete cover), which depends on the corrosion rate of the steel after carbonation (Tuutti, 1982).

On the external surface of the pillars of the Church some areas are present where concrete has been largely damaged by corrosion (Figure 1); moreover, the presence of some “patch” repairs, which were carried out in the mid Eighties, indicates that concrete damage due to corrosion was already present when the age of the structure was less than 20 years. Many of these previous repairs did not succeed in preventing corrosion to occur again. Therefore, the pillars require an intervention that should remedy already existing damage and avoid future damage occurrence, preserving at the same time the original surfaces and materials of the pillars and reducing their alteration.

**Figure 1.** a) view of the Southern facade of the Church, and b) damage on a pillar

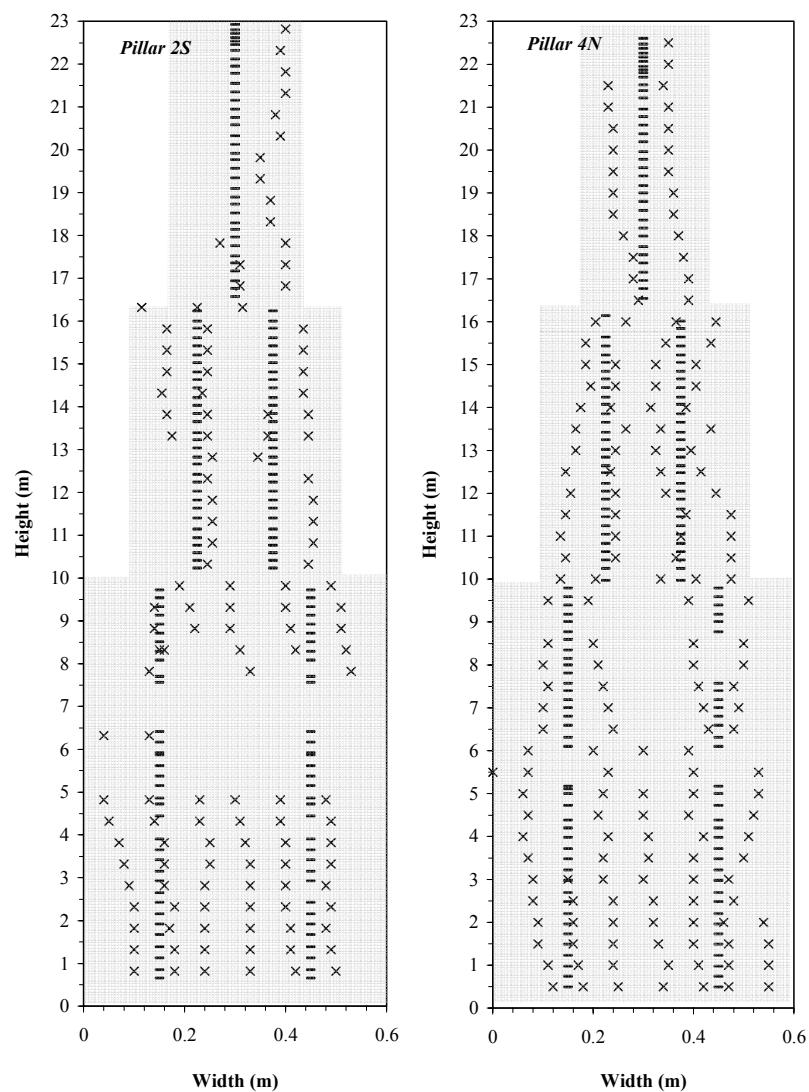
Figure 2 shows the position of longitudinal and transverse rebars detected on the pillars with a magnetic profometer. The diameter is 18 mm for longitudinal bars and 6 mm for transverse bars. Figure 3 shows the minimum and maximum values of concrete cover thickness of rebars as a function of the height of the pillars. Firstly it can be observed that the concrete cover shows a very uneven distribution: for instance on pillar 2S, moving from top to bottom, the transverse rebars have a cover thickness exceeding 30-40 mm in the highest part of the pillar (>17 m), then the cover decreases to values lower than 10 mm (13-16 m), and it increases again to 30-50 mm, with a great scatter between maximum and minimum values (8-12 m) and finally it reaches values of 10-20 mm in the lower part of the pillar. Also longitudinal bars showed a great scatter in the distribution of the concrete cover.

**Figure 2.** Position of longitudinal (×) and transverse (–) rebars (detected with a magnetic profometer) as a function of height and width of the pillars (grey area indicates the shape of the pillars)

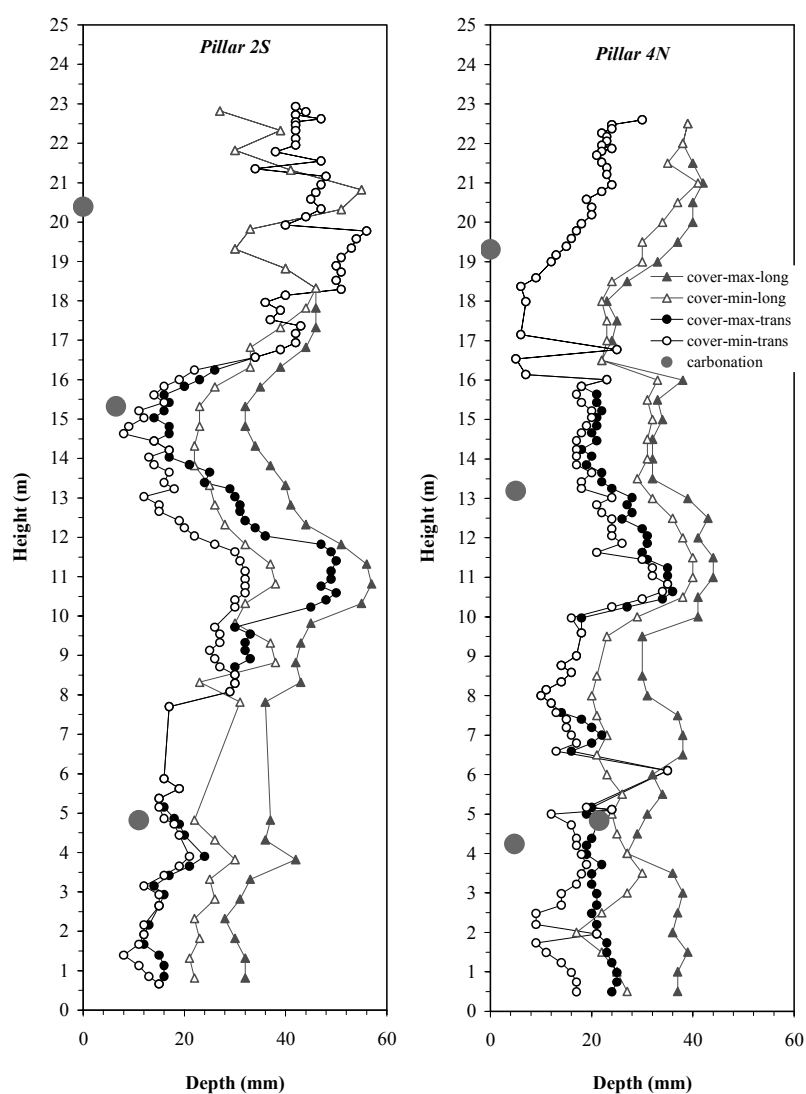
Figure 3 also reports the carbonation depths measured on the cores (pink circles). On pillar 2S the carbonation depth is: nil at an height of 20 m, 7 mm at 15 m and 11 mm at 5 m. In all cases carbonation depth is locally lower than the thickness of the concrete cover: this means that in the points were cores were taken, the rebars are still in alkaline

concrete and therefore do not corrode. However, considering the great variability of both carbonation depth and concrete cover, it is not possible to extend this conclusion to other parts of the surface as it is likely that in many zones (in particular in the lower parts of the pillars, where the carbonation depth is higher and the concrete cover lower) the rebars are in contact with carbonated concrete and, therefore, can corrode. This is what has already happened where the concrete is damaged.

**Figure 3.** Maximum and minimum values of concrete cover on longitudinal and transverse rebars and values of carbonation depths at the different heights of the pillars

Similar considerations apply for pillar 4N. Here, one of the cores had a carbonation depth higher than the minimum value of concrete cover; this measurement confirms that there are zones on the pillar where the rebars are in contact with carbonated concrete, but the concrete has not been damaged by corrosion yet.

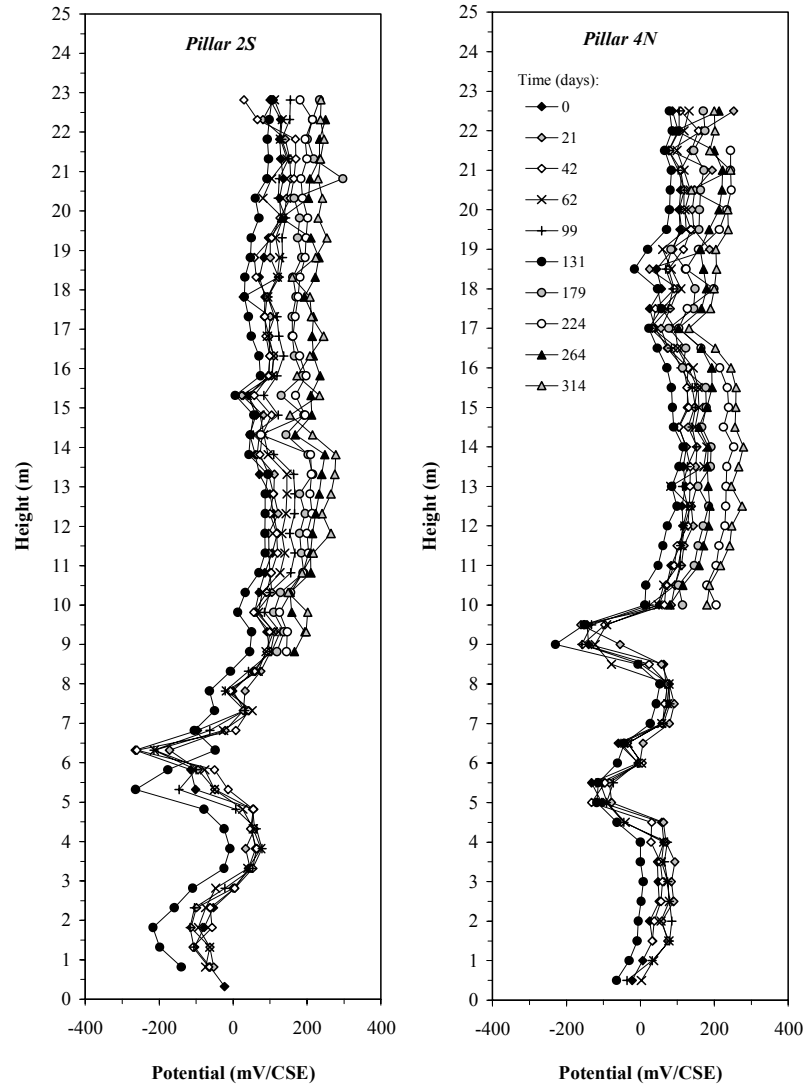
**Figure 4.** Natural variations of steel potential in time as a function of the height of the pillars (time 0 corresponds to the month of January)

Considering now the corrosion conditions of the rebars, that can be studied from corrosion potential values, the potential mapping on the pillars in their natural conditions (*i.e.* without artificial wetting) showed low values of steel potential (that indicate corrosion) almost exclusively where the concrete was already damaged. This can be seen for instance in Figure 4, that shows the potential values at different heights and at different times for the two pillars. On both pillars, the highest values of steel potential were measured on the highest part of the pillars where, even after natural variations in time, steel potential values were never lower than 0 mV/CSE. This indicates a scarce influence of environmental conditions (in particular humidity) on the corrosion conditions of the rebars, and confirm the sheltering effect of scaffolding. Potential values lower than or close to -200 mV/CSE, that indicate a higher probability of corrosion, were measured on pillar 2S around 5-6 m and on pillar 4N around 9 m and 5 m; all these zone are those where the concrete has already been damaged by corrosion.

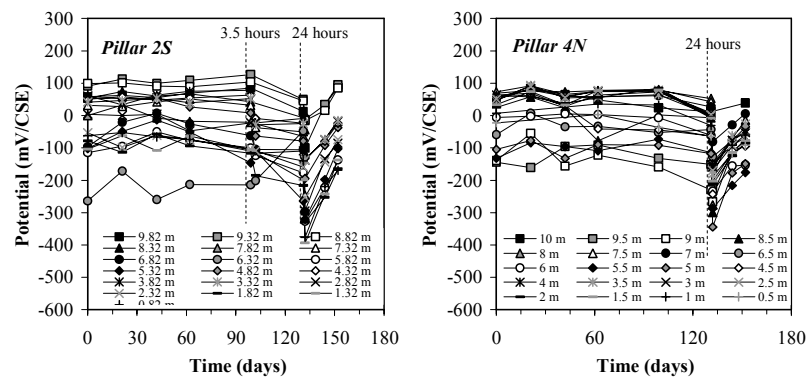
**Figure 5.** Steel potential at different heights (in the lower part of the pillars, <10 m) as a function of time. Artificial wettings and their durations are also indicated

When the concrete surface was artificially wetted to investigate the corrosion conditions of the steel in moist concrete, potential trends shown in Figure 5 were obtained. Since high values of steel potential can be representative both of dry alkaline concrete and dry carbonated concrete, this comparison allows to distinguish between the two cases, as steel in carbonated concrete is expected to undergo a potential decrease after wetting which is much higher than the one for alkaline concrete. For practical reasons, only the lowest part of each pillar (<10 m) was wetted (this lower area was also chosen later for the trial of application of repair treatments). It can be seen that a considerable decrease of steel potential is observed after wetting the concrete surface for 24 hours: on pillar 2S the average potential decrease is 120 mV and on pillar 4N 167 mV. The average potential reached after wetting is -200 mV/CSE for both pillars, with values as low as -350/-400 mV/CSE,

that are typical of actively corroding steel. The wetting of 3.5 hours, which was carried out only on pillar 2S, does not cause significant variations of steel potential (the average decrease was 30 mV). These results show that, although in dry carbonated concrete it is mainly the steel in damaged concrete that suffers corrosion, when the concrete is wet all the rebars in contact with carbonated concrete are actively corroding.

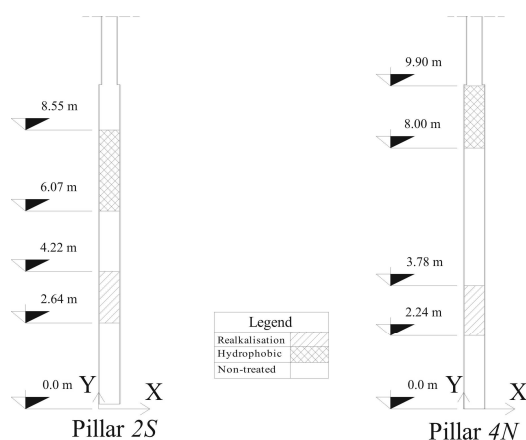
**Figure 6.** Zones where the treatments were applied on the two pillars

Two repair techniques were applied on selected zones of both pillars. The heights where they were applied are indicated in Figure 6. The non-treated area was used as comparison to evaluate the effectiveness of the treatments. The application of electrochemical realkalisation (Subsection 3.1) and hydrophobic treatment (Subsection 3.2) will be briefly described and then their effectiveness will be discussed (Subsection 3.3). Before the application of the treatments, cracked and damaged concrete cover was repaired with a commercial repair mortar.

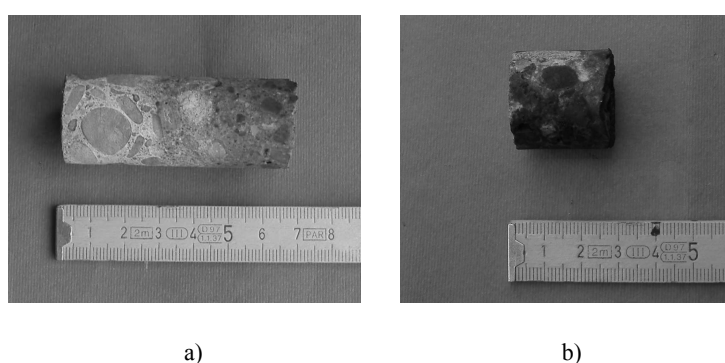
**Figure 8.** Phenolphthalein tests carried out on cores taken from pillar 4N: a) before realkalisation at height of 4.83 m, and b) after realkalisation at height of 3.50 m

functioning was checked by means of potential and current measurements. At the end of the treatment, cores were taken from the concrete to check its alkalinity. Figure 8 shows, as an example, a comparison of the phenolphthalein test carried out before and after the application of the treatment, on two cores taken in nearby areas. It can be seen that initially the carbonation depth was of several tens of millimetres, while after the treatment the concrete was completely alkaline. All the cores that were taken after the treatment turned out to be completely alkaline, indicating that the treatment was completed successfully.

On the pillars of the Church, electrochemical realkalisation was applied with a current density of  $1 \text{ A/m}^2$  with respect to the rebar surface for 3 weeks. For the anodic system a mesh of activated titanium and cellulose pulp soaked with a 1 M solution of sodium carbonate ( $\text{Na}_2\text{CO}_3$ ) were used. During the treatment, its proper

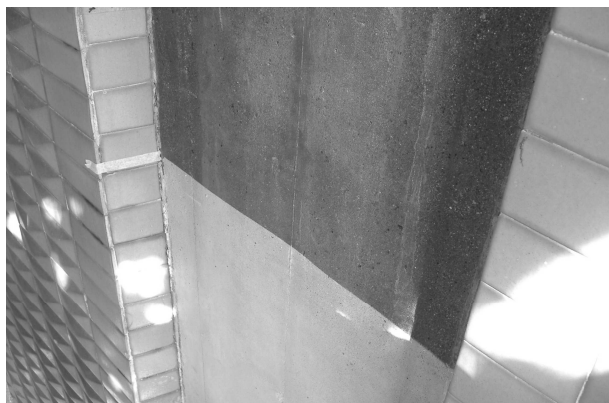
**Figure 9.** Surface of pillar 2S during artificial wetting (the lower part is treated with hydrophobic coating)

Hydrophobic coatings are made of water repellent substances and are applied on the surface of the concrete to reduce the ingress of water and aggressive substances dissolved in it, allowing at the same time its evaporation. They allow to reduce the capillary absorption of water but, keeping the pores dry, they do not affect the ingress of gaseous substances such as carbon dioxide. They can be used in the repair of carbonated concrete structures because they reduce the corrosion rate of rebars maintaining the concrete dry. On the pillars of the Church a commercial product based on silicon resins in water solution was used. Figure 9 shows the surface of pillar 2S treated with the hydrophobic coating during an artificial wetting.

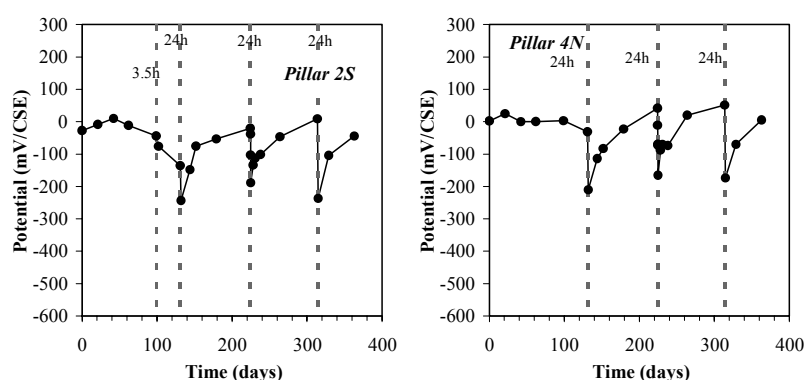
artificially wetted conditions. The trends of average potential on the three zones (non-treated, hydrophobic and realkalisation) are shown in Figures 10-12. The application of hydrophobic treatment is indicated by a grey dotted line, while the application of electrochemical realkalisation is indicated by a shadowed area; also the artificial wettings and their durations are shown. It can be seen that hydrophobic treatment cannot completely avoid the wetting of the concrete in contact with the steel, as it is shown by the potential decrease after 24 hours of artificial wetting. However the steel potential after 24 hours of wetting progressively increases, and it is always higher than the potential in the non-treated areas, indicating some effect of the surface coating (it should be noted that before the application of hydrophobic treatment the potential in the non-treated areas was more positive than in the areas where the treatment was applied, in particular on pillar 4N).

**Figure 10.** Average steel potential on the non-treated zones. Blue dotted lines indicate artificial wettings and their duration

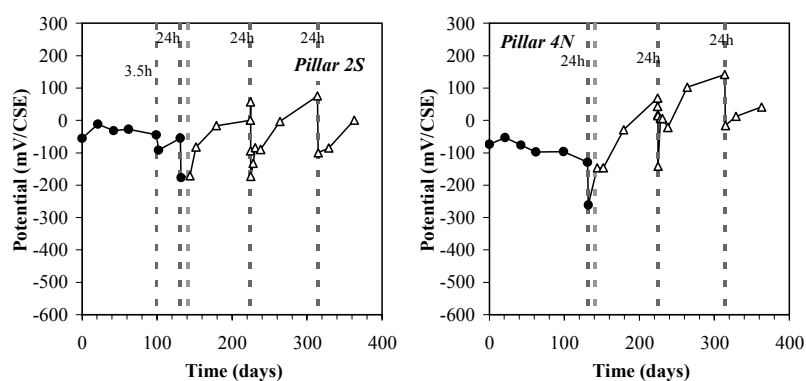
**Figure 11.** Average steel potential on the zones with hydrophobic treatment. Grey dotted lines indicate application of hydrophobic treatment

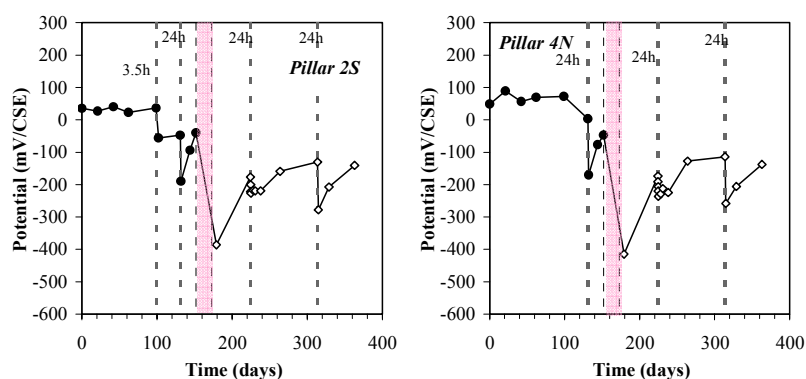
Electrochemical realkalisation brought about very negative potential values (due to the cathodic polarisation), around -800/-1200 mV/CSE during the application of the treatment. Potential values in this area remained lower than the initial values and than the values in the other zones, even after 6 months from the end of the treatment. In this case a long term monitoring of steel potential is necessary to assess the corrosion conditions of the steel. However the lower potential decrease after wetting, compared to non-treated areas, is consistent with reduced corrosion rate.

**Figure 12.** Average steel potential on the zones subjected to electrochemical realkalisation. Shaded area indicates duration of treatment
