# Fallingwater Part 1: Materials-Conservation Efforts at Frank Lloyd Wright's Masterpiece

NORMAN WEISS, PAMELA JEROME, and STEPHEN GOTTLIEB

**A 13-year-long investigation of deterioration mechanisms, along with prototype treatments, has yielded a better understanding of the nonstructural pathology of materials deterioration at a twentieth-century architectural icon.**

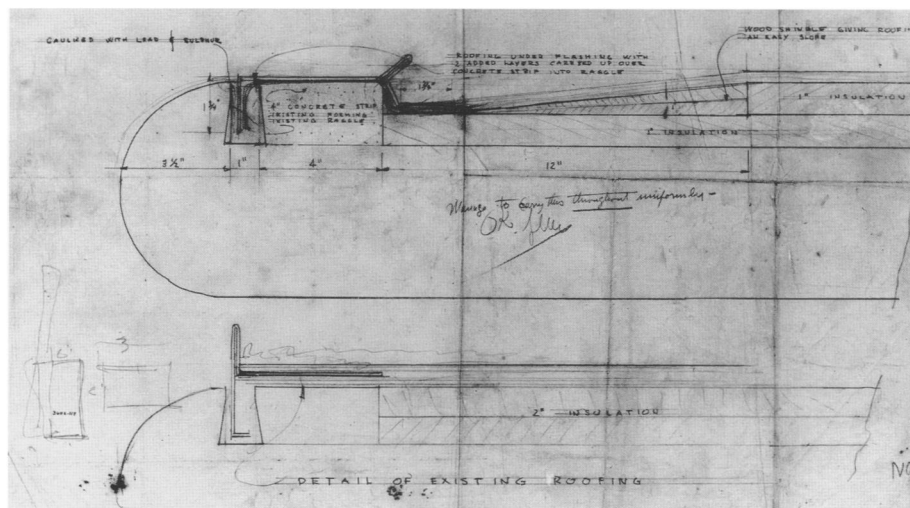
Fig. 4. The flashing, although not original, is similar to a detail shown on this Frank Lloyd Wright drawing, "Detail of Existing Roofing" (undated drawing), referred to as drawing 3602.117 by the Frank Lloyd Wright Foundation. That this drawing uses the word "existing" seems to indicate that the roofing termination on the roof rolls was still being considered even after the roofing was installed. The first detail shows the configuration of the typical gravel stop described by Wright in 1938 in *The Architectural Forum*. The drawings of Frank Lloyd Wright are copyright ©2001 The Frank Lloyd Wright Foundation, Scottsdale, Ariz.

flashing was to create shallow gutters, but there is insufficient slope for drainage. Flashing was not installed where the trellis abuts the parapets, although it is indicated on the drawing.

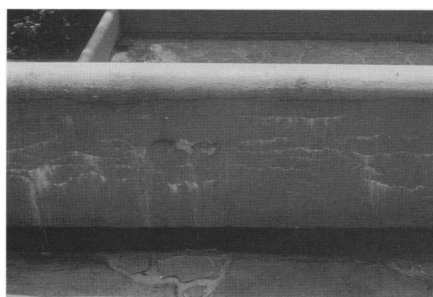
Fig. 5. The cold joint resulting from the construction of the rounded parapet top was clearly visible in the past. These cracks allowed water to flow between the stucco and concrete and exit in horizontal lines lower in the wall, characterized by calcium carbonate deposits. Photograph by WASA.

concrete solved some problems for Wright and created others. At the parapet cold joint, surface cracks allowed water to flow down behind the stucco and exit in fine, irregular horizontal lines (with deposits of calcium carbonate) lower in the wall (Fig. 5).

The majority of repairs have worked well. Materials and methods for filling hairline cracks and losses in the stucco were developed in 1993 by one of the authors (Weiss) and Paul Cappelli, a sculpture restorer. Parapet cold joints were cut in a dovetail shape, and they were pointed (about 1/2 inch in depth) with a fine-grained, low-shrinkage mortar. Exit cracks on the lower half of the parapets were left open (beneath the paint coating) to permit water to escape.<sup>47</sup> Minor work is currently performed by Fallingwater's maintenance staff. Most concrete repairs, including the 1998 patching of three beams that anchor Kaufmann Sr.'s terrace to the north rock, utilize Renderoc HB (a polymer-modified cementitious patching compound by Thoroc, formerly Fosroc).

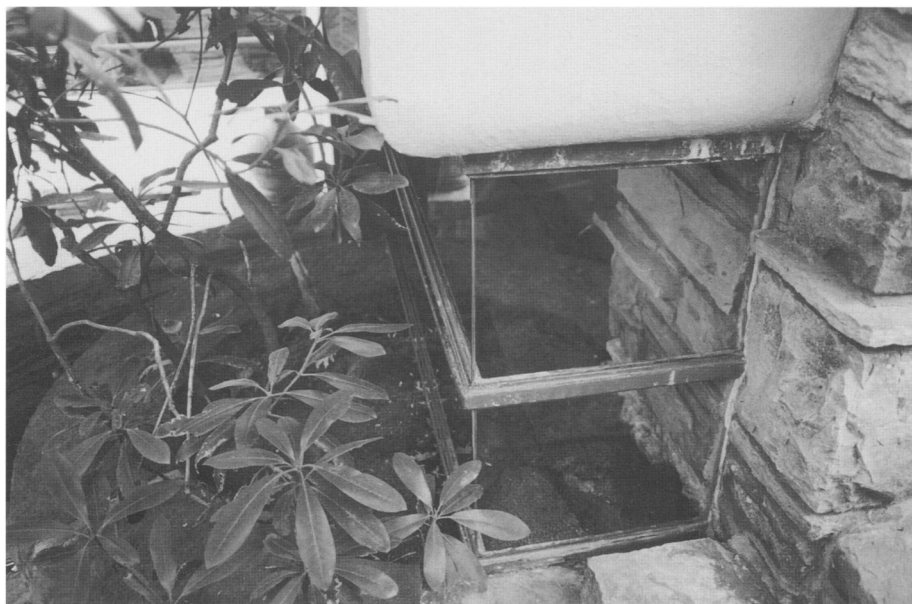
Fig. 6. Fixed panes of glass sometimes terminate directly into stone walls. These lack waterproofing details of a standard frame. In addition, corrosion occurs at window heads as a result of the rounded edge of the concrete soffits and the lack of metal drips at the main house's fixed windows. Photograph by WASA.

The lack of a drip at the underside of the roof rolls continues to be the chief source of moisture penetration into the window heads. Where metal drips exist in the frames, they are inadequate. Water falling from them tends to pond on the stone sills, then penetrates the window frame under the bottom rail.

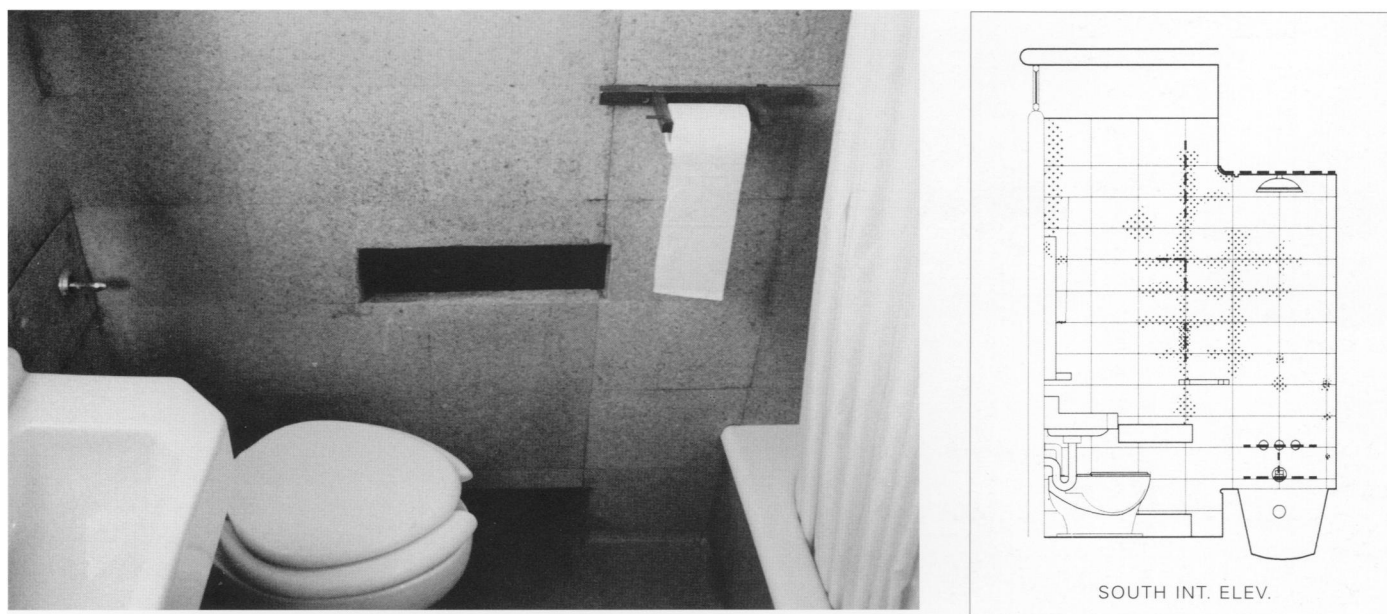
Fig. 7. Photograph and detail of drawing from the Existing Conditions Survey, showing the condition of the guest bathroom in the main house. Drawing by WASA.

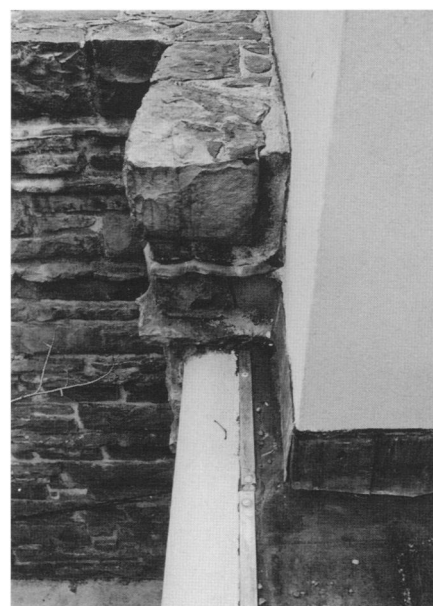
Overall, the roofs are in fair-to-poor condition. Many exhibit patches and pinholes. Along roof edges, the membrane is secured with "hit"-fastened termination bars (Fig. 8). The fasteners are spaced 12 inches on center, instead of the recommended 6 inches. Because of the unevenness of the concrete, the connection is not tight. All bars exhibit failed sealant along their edges and failed gaskets at the "hit" anchors (impact-expansion anchors); either failure is a potential source of moisture entry. Drains are often located at the high point, causing ponding. Pea gravel is sparse at most roofs, permitting exposure of the membrane in certain areas to full ultraviolet radiation.

Fig. 8. The existing EPDM membrane is secured with "hit"-fastened termination bars. Both the sealant along their perimeter and the gaskets at the "hit" anchors have failed. The complicated nature of waterproofing diverse construction materials — stone and concrete — where they abut is self-evident. Photograph by WASA.

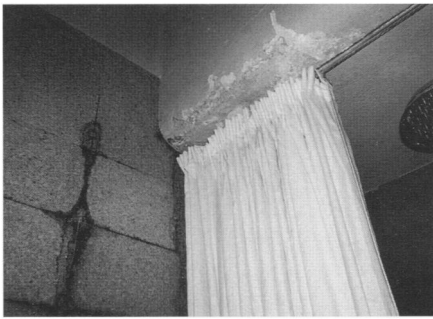
Fig. 9. Moisture infiltration in the main house's guest bathroom continues to damage both the plaster and cork-tile finish. Photograph by WASA.

Most ceilings and walls in both the main house and guest house have a cement-plaster finish. Where chronic leaks have occurred, there is evidence of staining, blistering, paint and plaster failures, cracking, and loss of cork-tile adhesion. Much of the patching of cracks and superficial spalls has failed.

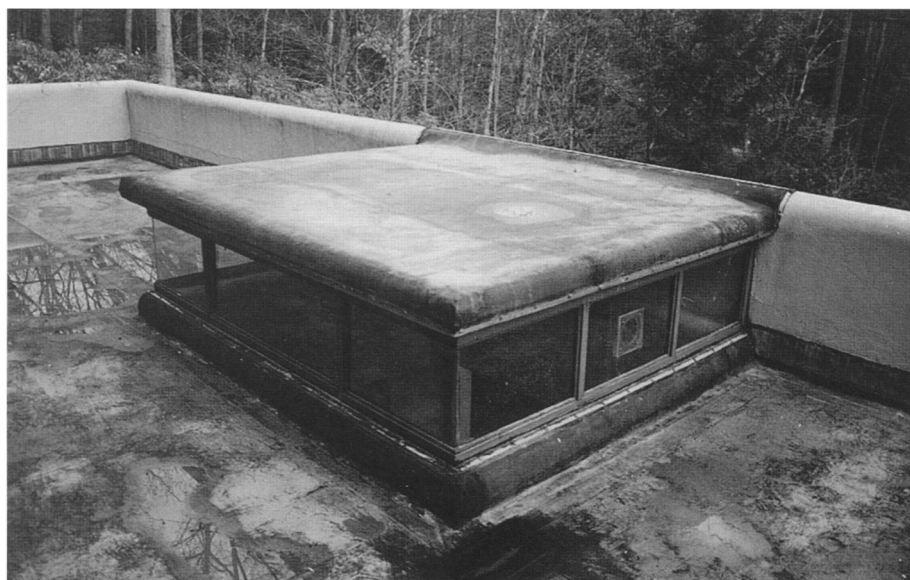
A monitor also covers part of the guest-house bathroom, where similar problems are occurring. Damage to the

plaster and paint is extensive, as is the detaching of the cork-tile finish. Moisture measurement strongly suggests that water is entering where the monitor intersects the roof and the parapet, the latter a particularly awkward detail (Fig. 10). The familiar problem of the termination bars and "hit" anchors is pronounced here.

Fig. 10. The monitors are particularly difficult features to waterproof. This one is located over the guest-house bathroom and is responsible for substantial damage to the interior finishes. Photograph by WASA.
