# Fallingwater Part 2: Materials-Conservation Efforts at Frank Lloyd Wright's Masterpiece

PAMELA JEROME, NORMAN WEISS, and HAZEL EPHRON

**Following a 13-year study of building behavior and conservation techniques, Fallingwater's challenging five-year-long restoration is nearing completion.**

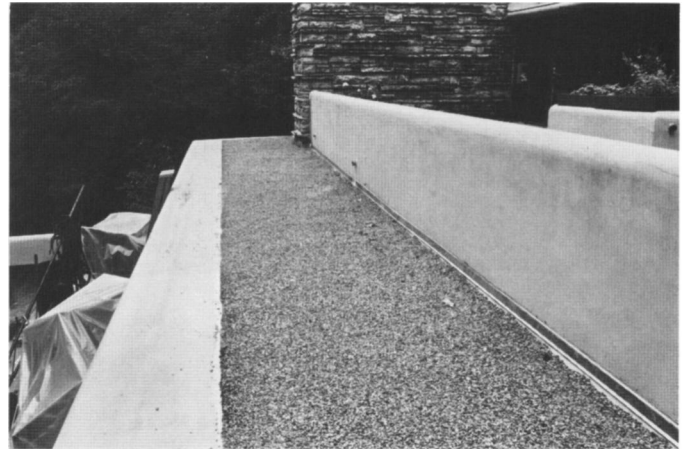
Fig. 4. At the roof-roll edge, the finished base flashing was coated with an elastomeric paint, making it virtually invisible. All photographs by WASA, unless otherwise noted. Courtesy of Western Pennsylvania Conservancy.

was used, thus solving the difficult issue of how to terminate the roofing on the roof rolls (Fig. 3).<sup>11</sup> The liquid-membrane base flashing was applied to the midpoint of the roof roll and painted with an acrylic elastomeric paint (PPG Pitt-Flex) to match the stuccoed surfaces, creating a virtually invisible termination (Fig. 4). (In the previous system, the EPDM membranes had been secured with termination bars fastened with impact-expansion anchors, which failed.) Where base flashing abutted irregular stone walls, a mix of one part Type II gray portland cement to two and one-half parts sand was used to parge the substrate smooth.

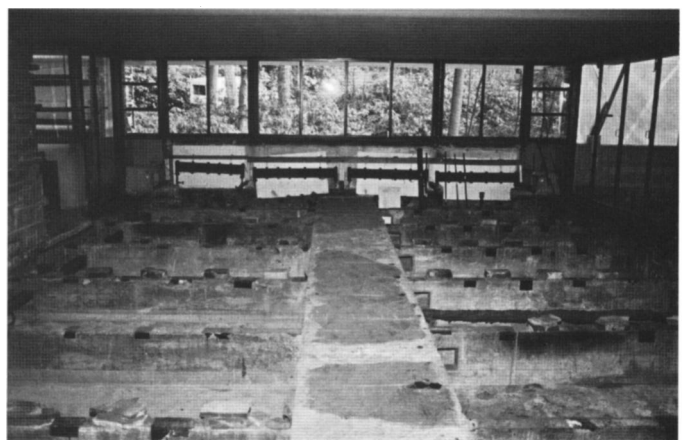
Fig. 6. The preeminent room of the house, the living room, was dismantled and the floor removed in order to grout the cracks in the cantilever beams prior to post-tensioning. One of the four main cantilever beams is visible at the center of the photograph, with concrete joists abutting it to either side.

ing, thus eliminating the potential for substantial lifting of the living room slab during the structural intervention (Fig. 6). (The slab had deflected as much as seven inches as a result of the failure of the main cantilever beams.)

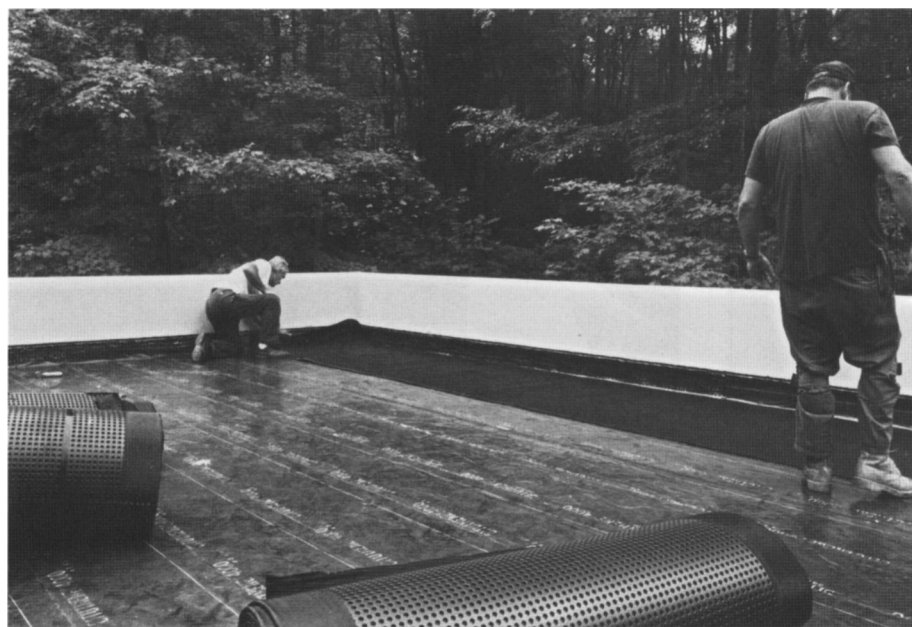
Fig. 7. Because the finished surface of the terraces consists of flagstones, the waterproofing is an IRMA (inverted-roofing-membrane assembly) system. Drainage mat was laid over the three-ply waterproofing on the master-bedroom terrace.

To permit proper subsurface drainage and to provide ventilation above the membrane, thus preventing frost damage, a drainage mat (¼-inch-thick Amer-

drain 350, manufactured by American Wick Drain) was laid over the finish ply (Fig. 7). (At some locations, protection board was substituted because of clearance issues.<sup>15</sup>) In addition, for the first time, bilevel sumped drains (1610 drains with perforated stainless-steel extension collars, manufactured by J. R. Smith) were installed rather than the original system of copper tubes (Fig. 8).<sup>16</sup> This substitution required minor cutting of surrounding flagstones so that flat bronze drain strainers could be installed. The extension collars were wrapped in filter fabric (Mirafi FW700) to prevent clogging.

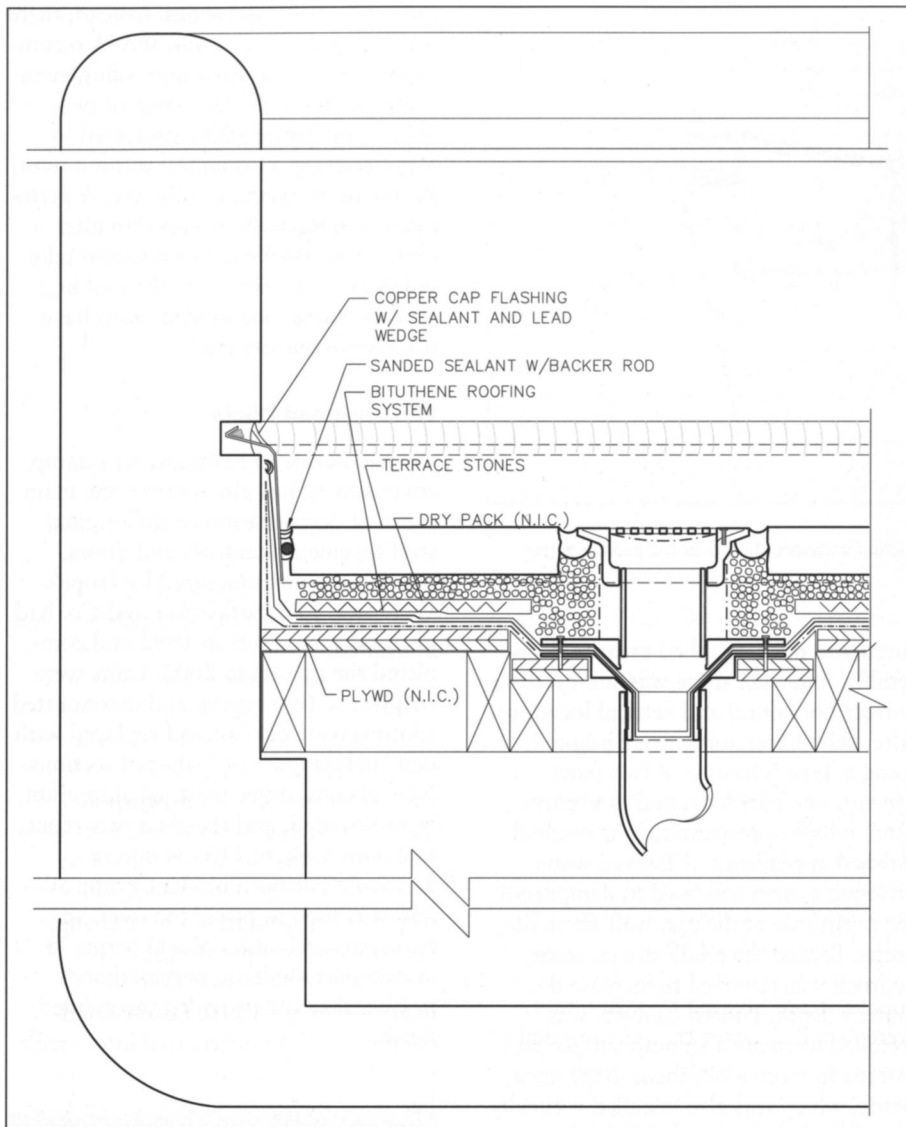
Fig. 8. Detail of a bilevel sumped drain installed on the terraces. These drains replaced the original copper tubes, which could not be integrated properly with the waterproofing and did not permit subsurface drainage.

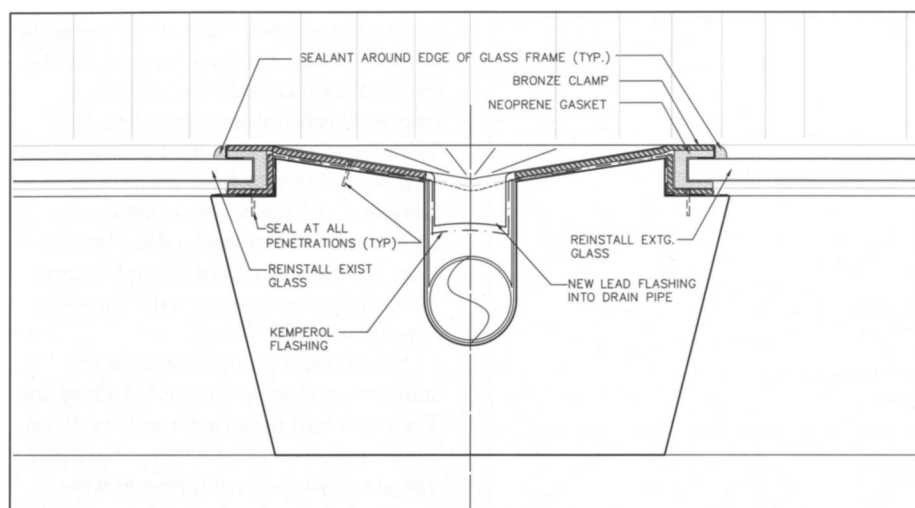
Fig. 9. Detail of the skylight, showing fleece-reinforced liquid waterproofing over the bronze angle clamps.

Small, square skylights that also hold light fixtures in the ceiling of the covered bridge suffered from reoccurring leaks. When the flagstone roof was rewaterproofed, bronze angle clamps with neoprene gaskets were installed at these locations as well.

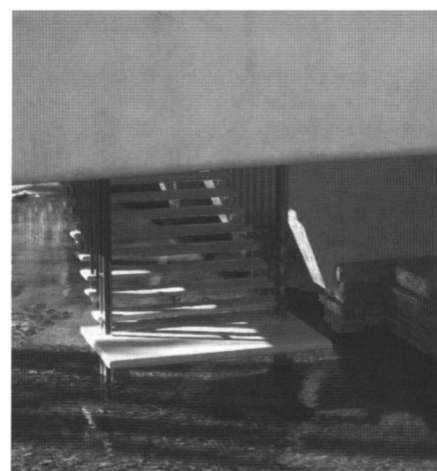
formerly known as Renderoc HB. However, the concrete stairs to the stream were particularly troublesome. Supported on painted, flat-steel straps that are partially embedded in the treads, the stairs are largely hung from the soffit of the living-room slab. The stairs are occasionally submerged by the stream, resulting in corrosion of the steel straps. In 1991, under WASA's direction, spalls in the concrete steps were removed, and the steel was blast-cleaned, primed, and painted. Both trowel-applied and poured-in-place repairs were attempted, but both failed due to the continuing corrosion of the embedded steel.

Fig. 10. The stairs to the stream were a 1950s reconstruction, which continued to deteriorate due to the corrosion of the embedded steel straps. During the recent restoration, the stairs to the stream were rebuilt again, this time using stainless steel.

These stairs had been rebuilt in the late 1950s after debris carried by the stream during a storm severely damaged them.<sup>21</sup> Because the existing stairs were not original, WASA, in collaboration with Robert Silman Associates, chose to reconstruct them using stainless-steel straps. Worcester Eisenbrandt, Inc., of Baltimore, Maryland, performed this work. The new straps were embedded in the living-room slab. In the process of probing to reveal the existing assembly, an interesting detail was uncovered: the straps were connected to turnbuckles concealed in the concrete. Formwork for recasting was slightly undersized to

permit the finished surface to receive the typical  $\frac{1}{4}$  inch of stucco. Existing lighting fixtures recessed into the bottom step were refurbished and reinstalled. The existing supports for the bottom step were different from the rest; they consisted of back-to-back angles anchored into the bedrock of the stream. They were replaced with stainless-steel T-shaped straps of essentially the same appearance (Fig. 10).

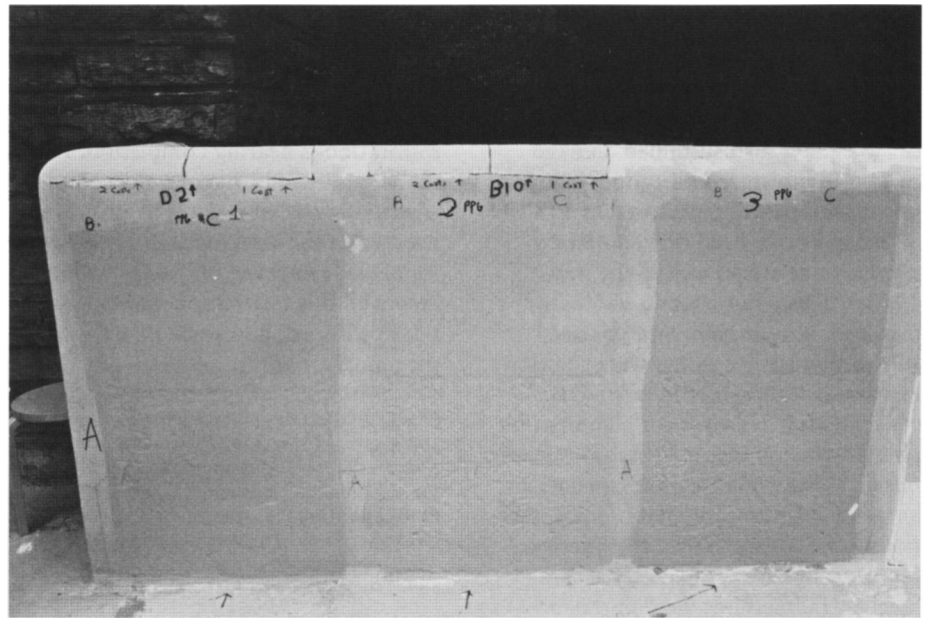
Fig. 11. Paint testing involved the review of approximately 120 variations, some of which are seen here, applied by four different manufacturers on vertical, horizontal, and rounded parapet top surfaces.

WASA reviewed the samples in October 2002 and again in March 2003. ProSoCo's BMC II exhibited failures similar to those of BMC 90. PPG's epoxy-based paints were considered too glossy for Fallingwater's aesthetic. The

Keim paint systems (modified potassium silicate) recommended the resurfacing of the stucco finish, a labor-intensive procedure that was deemed unacceptable and exhibited failures in the samples. Only Silin's Silith (silicone-modified potassium silicate) provided performance and application characteristics that were suitable. This system was also compatible with paint stripping using only the power-washing method.<sup>35</sup> WASA recommended that preparation also include application and thorough rinsing of D/2 Architectural Antimicrobial to remove biological soiling prior to painting. A large-scale application of Silith was performed to the stepped canopy in July 2003, but it exhibited erosion and irregular discoloration by October 2005.<sup>36</sup>
