Philip Johnson's Painting Gallery: Case study of a modernist earth berm roof replacement and restoration

Mary Kay Judy*

Key words: Philip Johnson; Glass House; earth berm; Modernism; sub-grade roofing

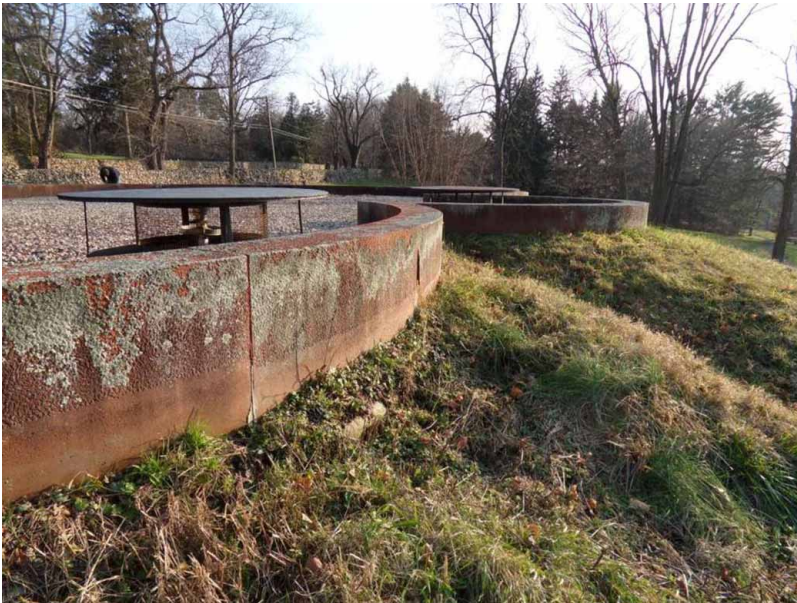
Physical examination of the exterior of the building revealed that the berm was no longer covering the roof deck or top of the rising wall in many locations (see [Figure 1](#)). Special attention was paid to the two locations from which exterior leaks were emanating: the main door and hallway. No other leaks or water damage were observed on the interior. The receding berm revealed multiple waterproofing treatments as well as the original butyl rubber member roofing, none of which were intended to be exposed to UV or weathering. The treatments included Grace Procor, Liquid Plastics and bentonite clay. The exterior examination also revealed exposed pieces of Hydroduct drainage that had been installed under the berm. The main roof drainage was concealed under a heavy layer of gravel ballast, but the drainline on the exterior passing through the copings was no longer connected to a downspout – a condition also exposed by the receding berm.

Figure 1. Redstone coping and receding berm at main roof during the investigation phase. (Mary Kay Judy)

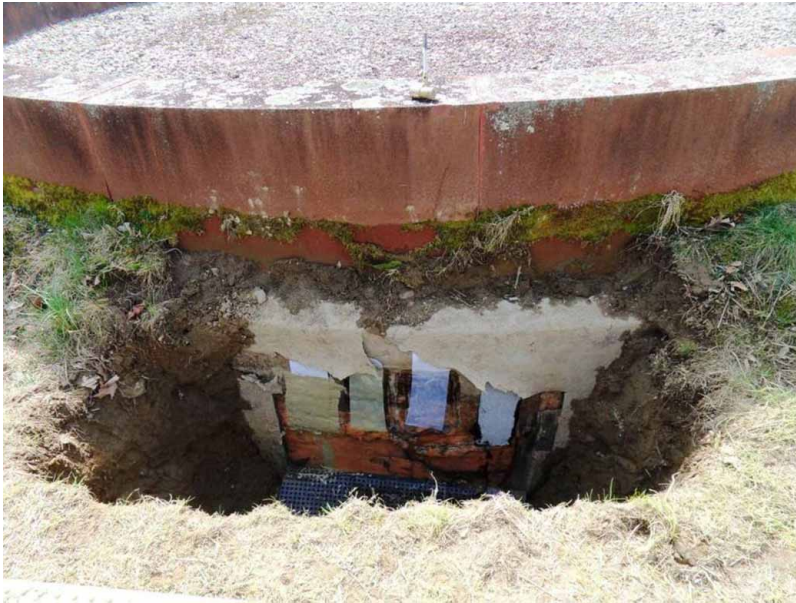
Figure 2. Kemper primer mock-ups at rising wall in trench probe. (Mary Kay Judy)

Kemper roofing was identified as an ideal candidate for the project since it could be applied directly to the roof deck substrate and lap on the rising walls, where it would self-terminate, eliminating the need for fasteners or penetrations. Within the product range, Kemper 2 K Pur was selected, since it was cold-applied and had very little odour and no fumes potentially dangerous to the collection. However, it was still unknown whether the Kemper would adhere to the Procor. Working with Kemper technical representatives, four different primers with 2 K Pur roofing were applied to an exposed, cleaned section of Procor in one of the trench probes (see [Figure 2](#)). Pull tests were then performed several days later, after allowing the mock-ups to fully cure. Pull tests revealed that the primer that provided the best adhesion was the existing manufacturer's primer for the 2 K Pur system chosen, as opposed to modifications made to the other primers in the mock-up. It was determined that the Kemper 2 K Pur system would be used on both the exposed main roof and the sub-grade roofs under the berm.

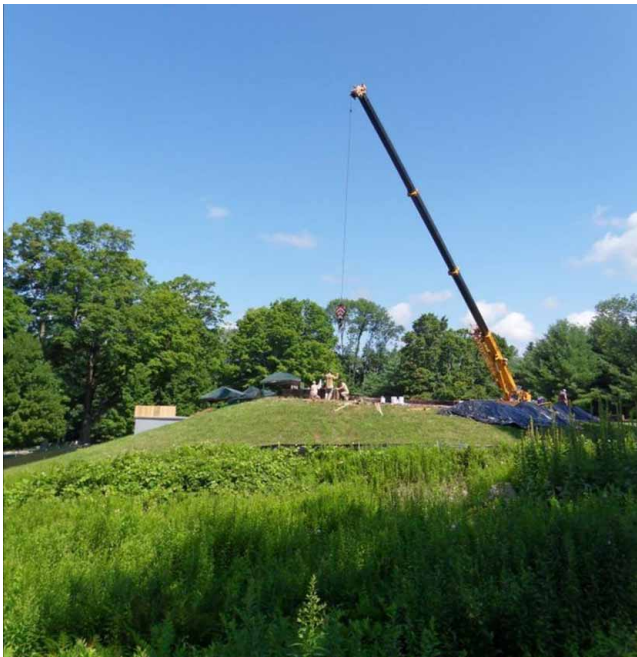
Figure 4. Site protection in place, the crane removing the copings stones from the main roof. (Mary Kay Judy)

The next step was the careful removal of the coping stones by crane (see [Figure 4](#)). Each stone was prepped by removing layers of sealant and caulking at the transverse joint to access the original dry set stainless steel conjoining pins located at each stone's midpoint. The pins were then cut within the joint, using a fine saw to prevent any damage to the surrounding stone. Each stone was protected and labelled before strapping and lifting with the crane. Stones were placed in order of

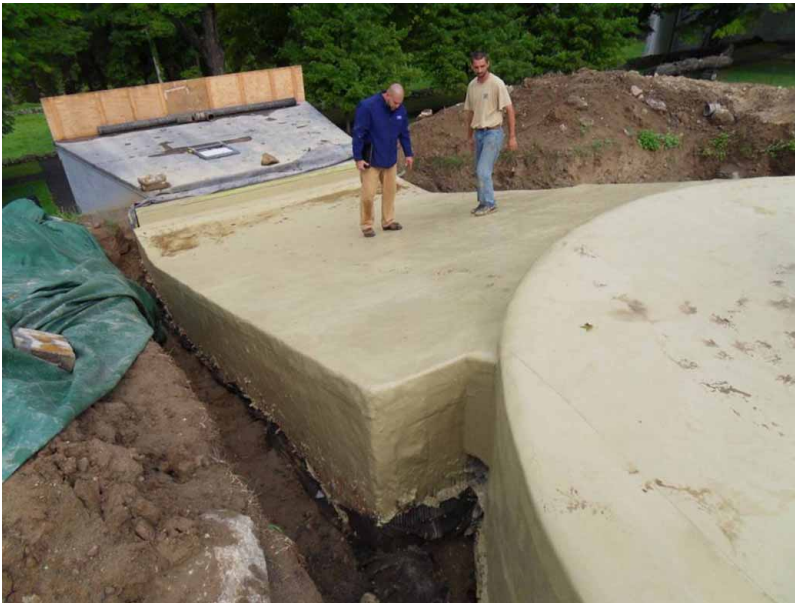
Figure 5. Kemper installed at sub-grade hallway roof and curved edge of main roof. (Mary Kay Judy)

The sequencing of the Kemper began with application at the main roof and subgrade roof rising walls to allow the Kemper at the roof decks to lap on to the flashed rising walls (see [Figure 5](#)). The Kemper liquid applied system lent itself well to the curved walls, unusual returns and meeting points of the roof levels allowing a monolithic installation at its completion.

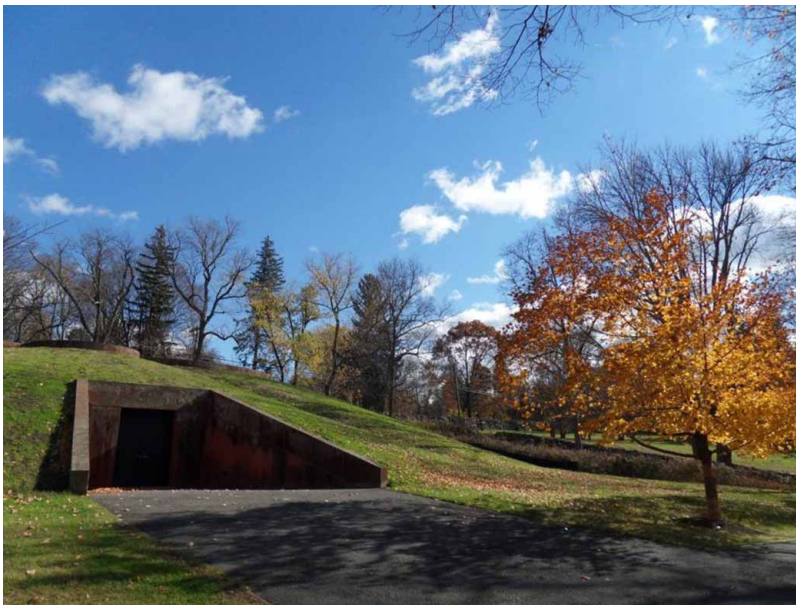
Figure 6. Completed roof replacement and berm restoration. (Mary Kay Judy)

The final scope of work was the actual berm profile restoration, which was accomplished by adding a new one-foot layer of premium topsoil to cover the entire berm, including the lower areas that had not been disturbed. The new layer of topsoil was seeded with a custom grass mix that had been curated by Johnson for the Glass House property (see [Figure 6](#)).
