Sydney Opera House

Paul Akhurst, Susan Macdonald & Trevor Waters

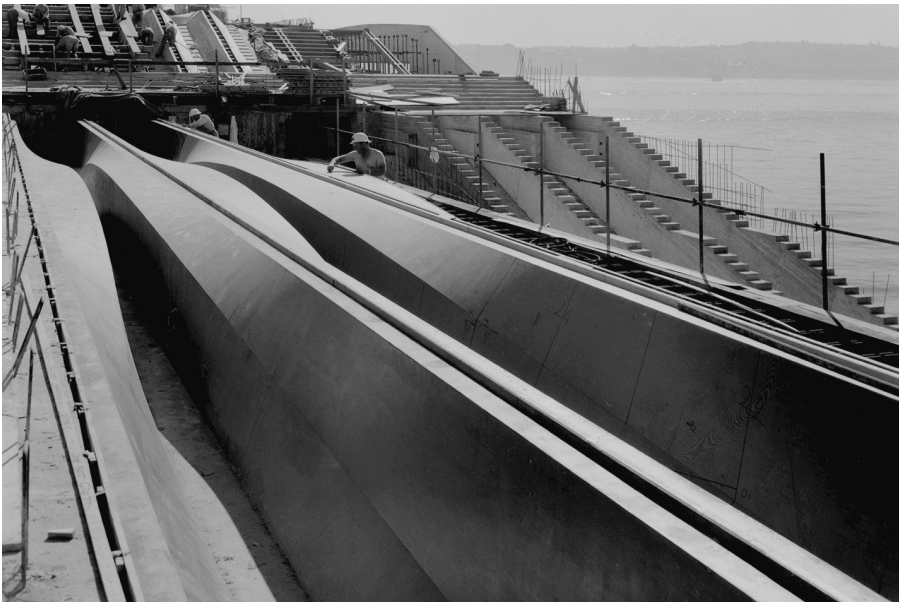
Figure 5 Large sheets of 3/16 inch plastic-faced plywood were used to line the formwork for the folded beams. Even minor damage involved the loss of the whole of that sheet, 1962. (Courtesy Max Dupain & Associates)

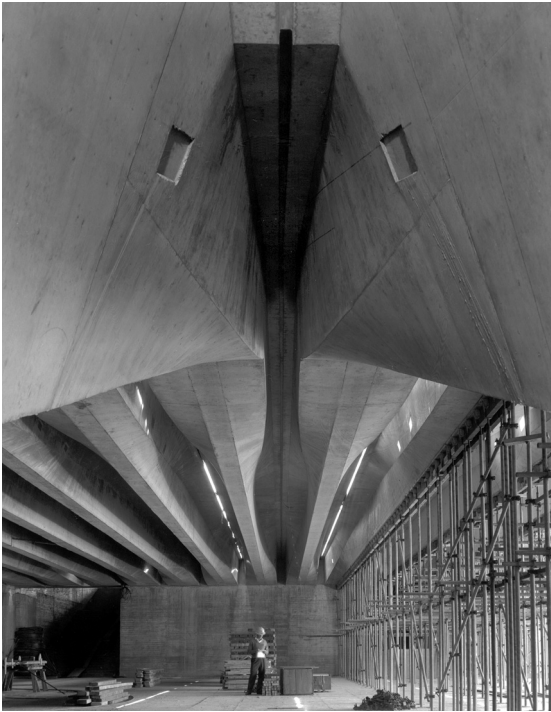
Figure 6 The special formwork called for by Ove Arup and Partners involved sinuous curves and elaborate setting out procedures for the soffits and beam sides. The tolerances demanded by the engineer were more consistent with precision joinery of cabinet making rather than formwork, 1962. (Courtesy Max Dupain & Associates)

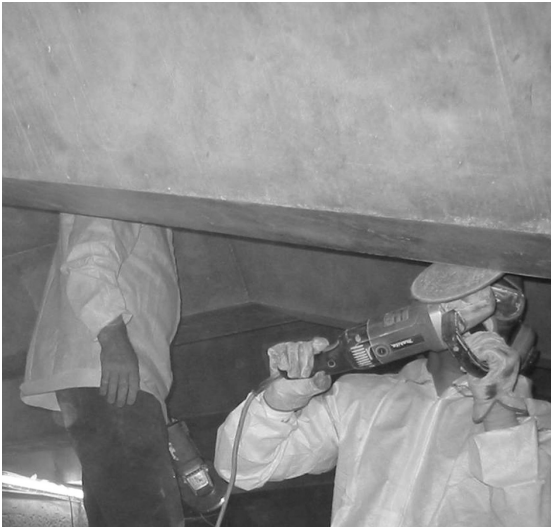
Figure 8 The surface of the beams was burnished to create a uniformly white surface. (Trevor Waters, 2003)

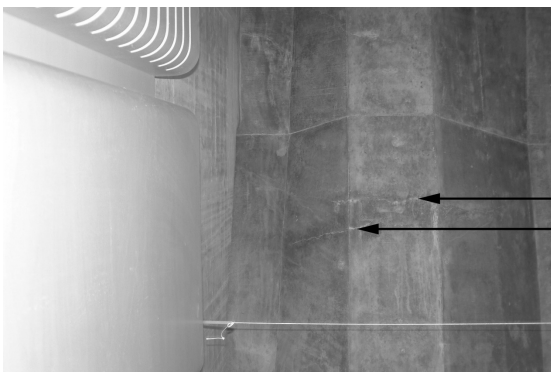
Figure 9 A photographic survey of the folded slab to the Utzon Room mapped the open crack and areas of water ingress. The arrows highlight the crack and leaching of the beam as a result of water penetration. (Trevor Waters, 2004)

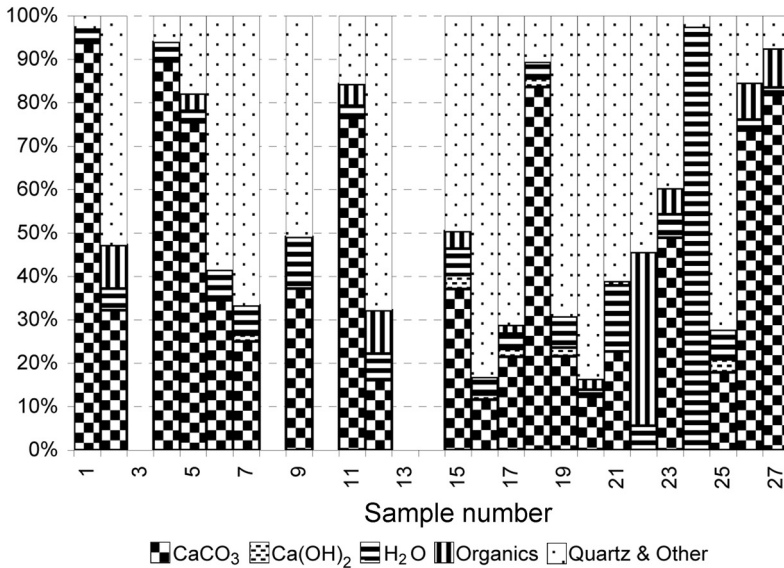
Table 3 Analysis of surface scrapings.

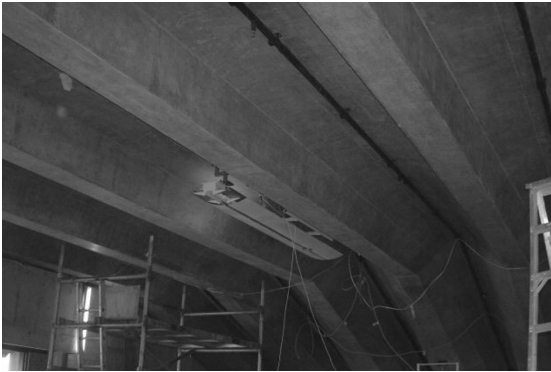
Figure 10 The folded concrete beams to the Utzon Room retain the original mottled and rust-stained finish that was evident in 1962 construction photographs. (Trevor Waters, 2003)

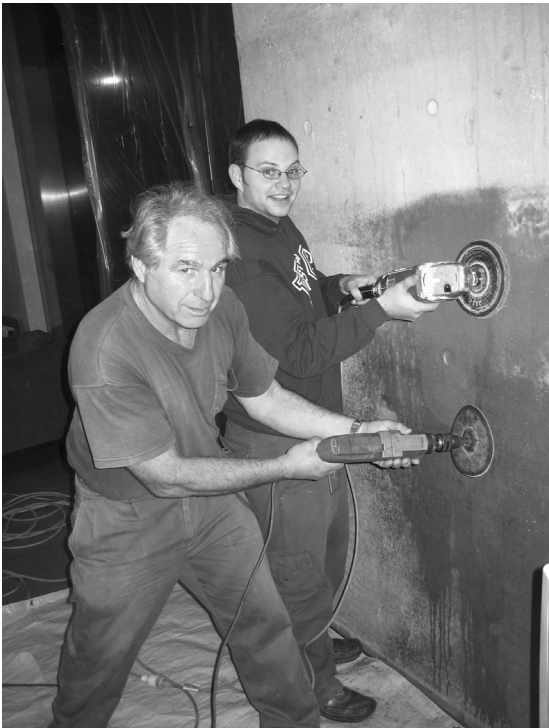
Figure 11 Steve Tsoukalas demonstrates the use of the original drill used to burnish the soffits of the freshly stripped concrete. The hardened concrete is currently 'reactivated' with a calcium bicarbonate solution that evens out the blemishes and fills the pores, creating a denser surface. This figure demonstrates the process only – correct safety procedures were followed when undertaking the task. (Trevor Waters, 2003)

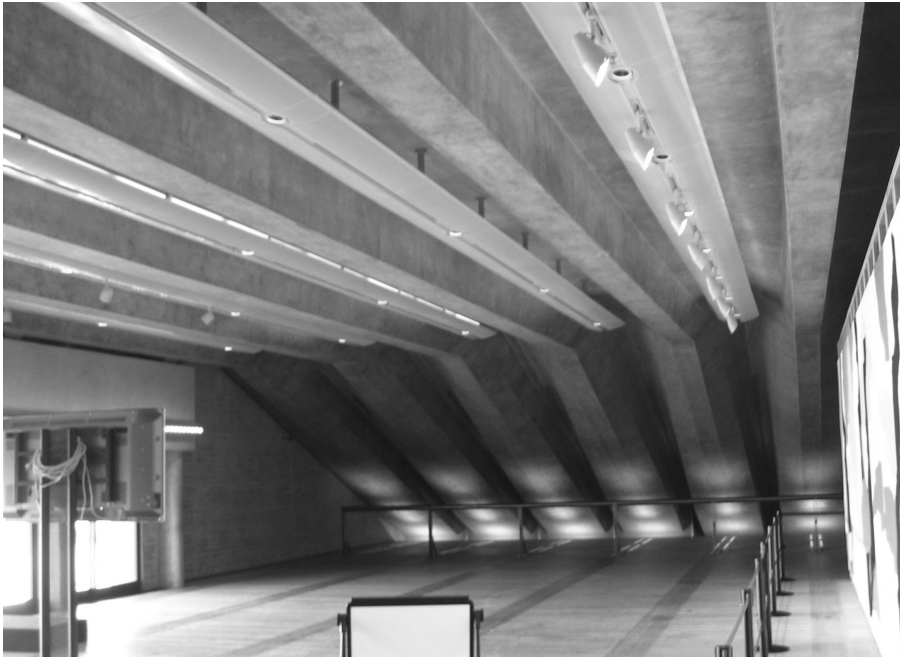
Figure 12 The Utzon Room presentation has been improved by the cleaning and treatment of the concrete without compromising the character of the concrete finish or having to remove early structural patches that help to tell the story of the place. The work sought to reinstate the authentic finish of the exposed concrete, which is such a strong aesthetic element in the building. (Trevor Waters, 2005)

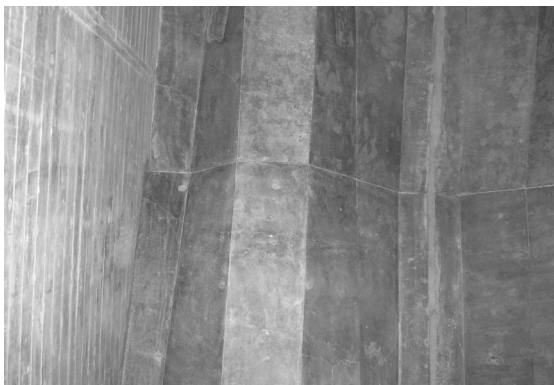
Figure 13 Visual inspection of the soffits confirmed that there were no apparent adverse effects from the cleaning process. (Trevor Waters, 2005)
