# Historic Fabric vs. Design Intent

Authenticity and Preservation of Modern  
Architecture at Frank Lloyd Wright's Guggenheim  
Museum

Angel Ayón

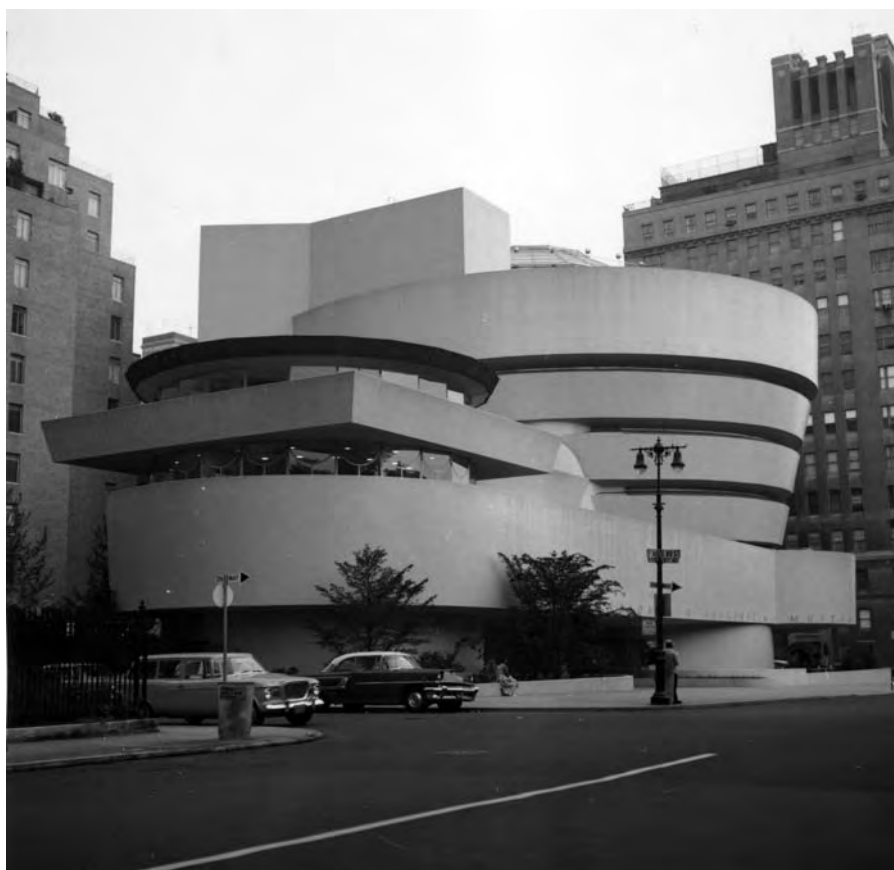
**Figure 1** Frank Lloyd Wright, Solomon R. Guggenheim Museum, New York City, built 1956–59 (© William Short, the Solomon R. Guggenheim Foundation).

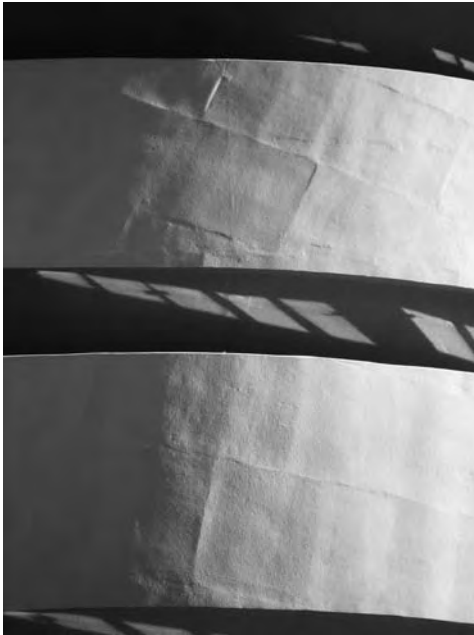
**Figure 5** Detail of Rotunda wall showing original formwork marks after exterior conservation work (© A. Ayón, WASA/Studio A, 2009).

The surface preparation required for installation of the CFRP, however, would have obliterated the original formwork marks. This subtle surface pattern was deemed culturally significant, not only as evidence of authenticity of craftsmanship, but also as an indication that Wright's vision for the Guggenheim was ahead of the construction means and methods available at the time (Figure 5).

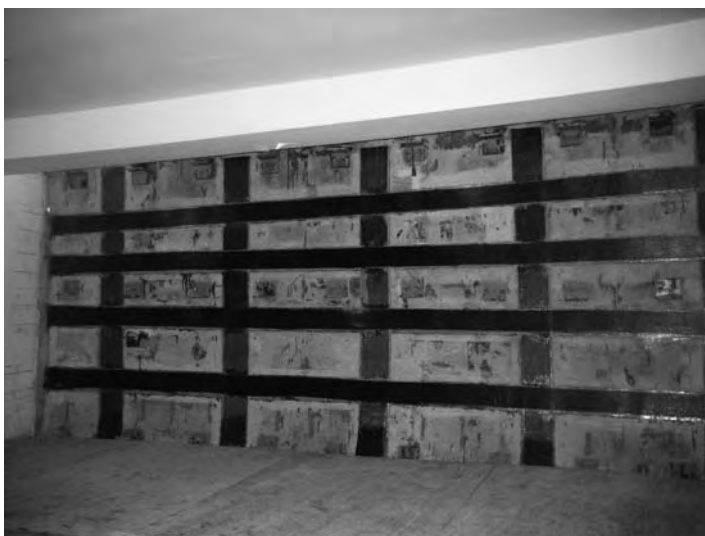
**Figure 6** Carbon fibre reinforcement at the interior face of the Guggenheim Rotunda's uppermost wall (© A. Ayón, WASA/Studio A, 2007).

When it was uncovered and confirmed that the horizontal reinforcement of the uppermost Rotunda wall was discontinuous, several structural repair solutions to re-establish the continuity of the reinforcement were considered. One of them involved wrapping the exterior surface with a surface-mounted carbon fibre reinforced polymer (CFRP). This innovative exterior repair

solution, in addition to remedying the most prominent structural deficiency uncovered during the project, would have also allowed both a comprehensive treatment of the multiple cracks on the deteriorated exterior concrete and attainment of the smooth surfaces that Wright originally envisioned, and the contractor failed to accomplish during the original construction.<sup>9</sup>

In this case, retaining the authenticity of the walls as built outweighed the temptation to implement the architect's well-documented, yet unrealized, design intent for the quality and appearance of the exterior concrete surfaces. To address the discontinuity of the horizontal reinforcement, Robert Silman Associates, PC, the project's structural engineers, conceived a CFRP reinforcement installed on the interior face of the wall, which was exposed for this particular purpose (Figure 6).

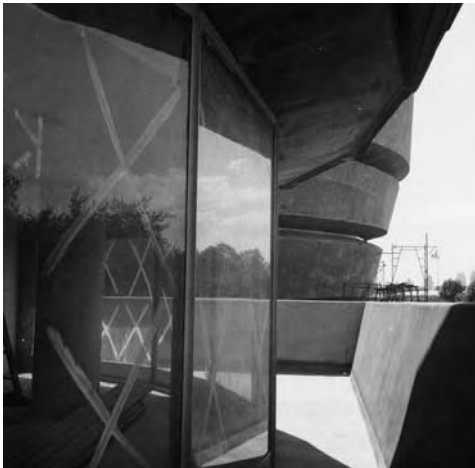
**Figure 8** Frank Lloyd Wright, Solomon R. Guggenheim Museum, original steel-frame glass walls during construction (© William Short, the Solomon R. Guggenheim Foundation).

frame glass walls leading to perimeter balconies. These glass walls were comprised of a single-glazed, non-thermally broken, galvanized steel-frame system. Unlike the Rotunda, they conveyed a sense of transparency and extroversion suitable for the non-exhibition spaces they were originally designed to be. They also helped to fulfil Wright's vision of organic architecture, where a building embraces, rather than separates, the indoor and outdoor environments that it is meant to demarcate (Figure 8).

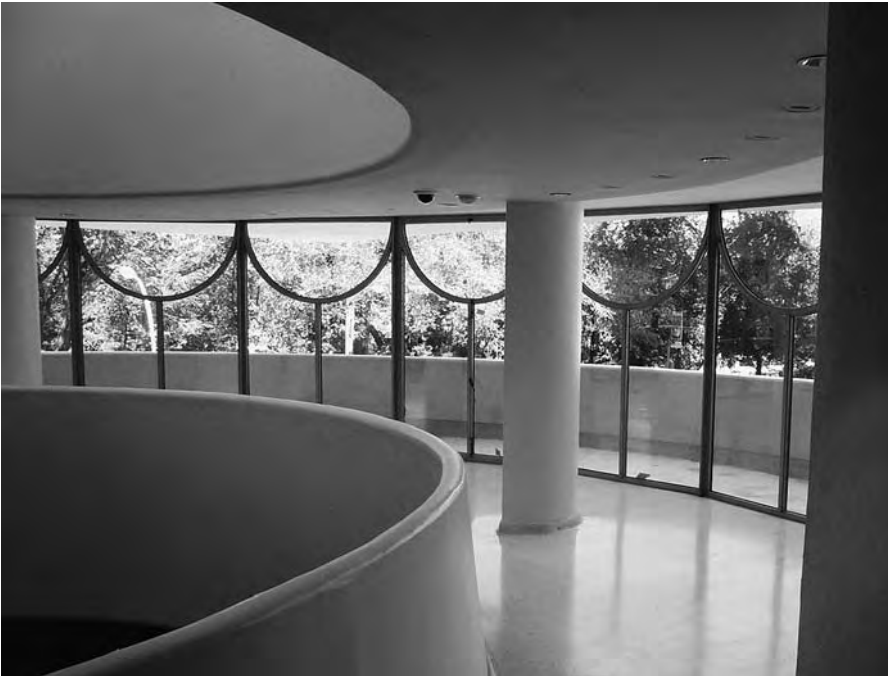
**Figure 9** Replacement thermally broken steel-frame glass walls, 3rd Floor Thannhauser Gallery (© The Solomon R. Guggenheim Foundation, 2008).

Despite the good physical condition of the steel-frame glass walls, their poor performance made replacement the more appropriate upgrade option. As a result, an unprecedented thermally broken steel-frame system, matching the appearance and sightlines of the original glass wall, was fabricated and installed, according to a unique design by WASA/Studio A and William B. Rose & Associates (Figure 9).<sup>10</sup> Representative samples of the original steel-frame enclosure were retained as part of the museum collection to ensure archival preservation of such a distinctive original historic feature.

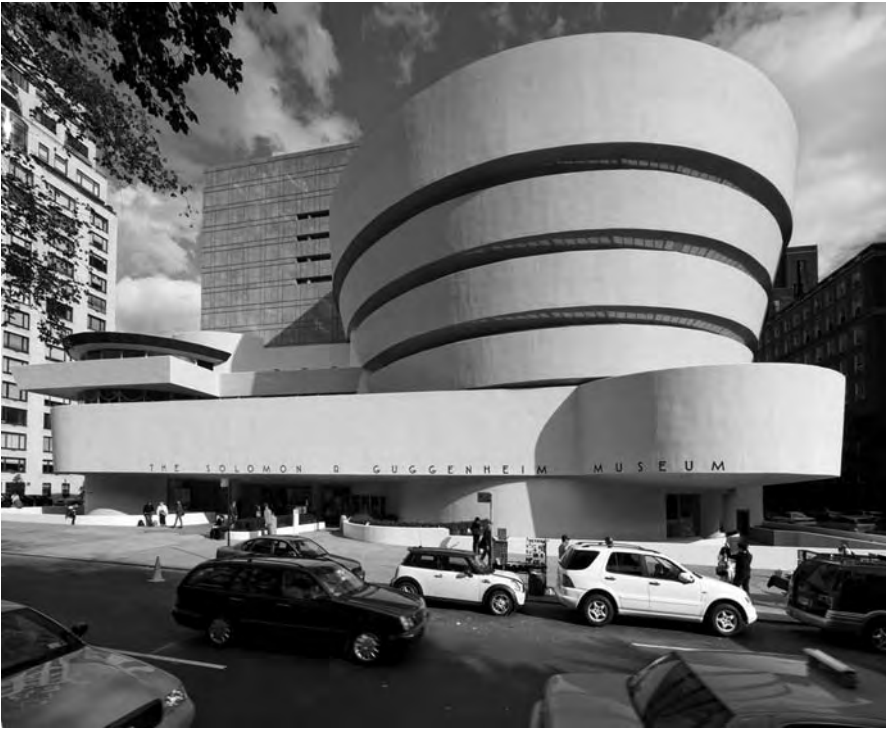
**Figure 10** Frank Lloyd Wright, Solomon R. Guggenheim Museum, New York City, built 1956–59. Gwathmey Siegel & Associates Architects, Addition and Expansion, built 1989–92 (© D. Heald, the Solomon R. Guggenheim Foundation, 2009).
