Source: *APT Bulletin*, Vol. 42, No. 2/3, Special Issue On Modern Heritage (2011), pp. 59-66

# Reglazing Frank Lloyd Wright's Solomon R. Guggenheim Museum in New York City

ANGEL AYÓN AND WILLIAM ROSE

**Performance and preservation requirements at a Frank Lloyd Wright Modern icon inspired the development of a thermally broken steel frame for insulated glazing.**

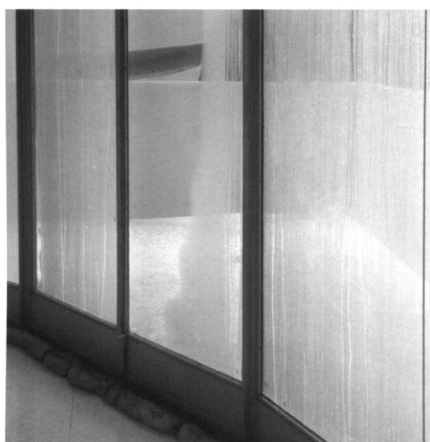
Fig. 2. Seasonal condensation at original fourth-floor interior steel-frame glass walls, photograph 2005. This and all other photographs by Angel Ayón, WASA/Studio A, unless otherwise noted.

55 percent relative humidity, not to fluctuate more than 1 to 2 percent in 24 hours, with an unacceptable range of below 42 percent and greater than 60 percent relative humidity and no sudden spikes)<sup>4</sup> allowed condensation to freeze and form icicles along the steel frames. To a lesser extent, similar condensation occurred during the summer, as the outdoor atmospheric water vapor condensed on the colder, exterior glass surfaces of the Thannhauser gallery.

Such seasonal condensation compromised the stability of the museum's indoor environment,<sup>5</sup> led to energy loss and increased demand for air-conditioning, imposed greater heating and dehumidification loads on the building's mechanical equipment, impaired indoor-outdoor visibility, and rendered the Thannhauser gallery unfit for exhibition display during cold seasons.

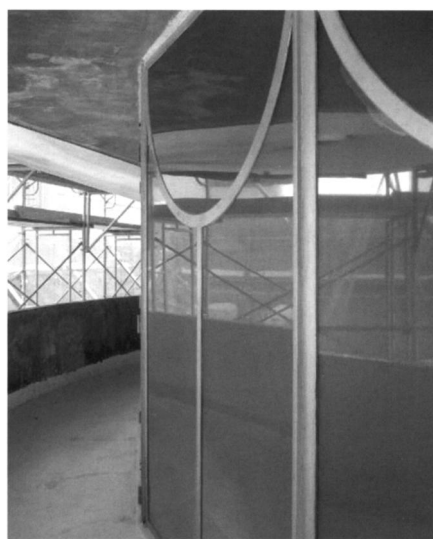
On the third floor of the Thannhauser gallery, new exterior storm windows with IG units had been installed at select locations, adjacent to the exterior face of the existing single-glazed enclosure. The steel frames encasing the new units increased the original sightlines, modified the exterior appearance of the glazed enclosure, and overshadowed its distinctive semicircular transom pattern (Figs. 3 and 4).

Fig. 3. Exterior view of existing original third-floor steel-frame glass walls, photograph 2006.

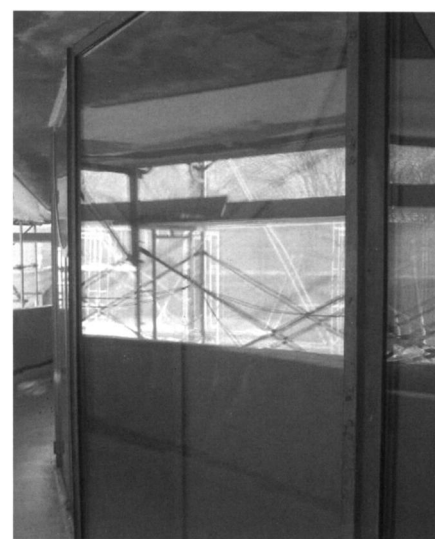
The insertion of IG units during the tests reduced condensation on the glass surfaces, if not eliminating it completely. The shallow glazing pockets of the original steel frames, however, afforded insufficient clearances to install IG units according to current industry standards. The proximity of the IG units to the existing frames had the potential to compromise the integrity of their edge seals and void the fabricator's warranty.

Fig. 4. Exterior view of storm window with insulated-glass units installed during a c. 1994 in-house retrofit, photograph 2006. The exterior glazing obscured the original steel frame.

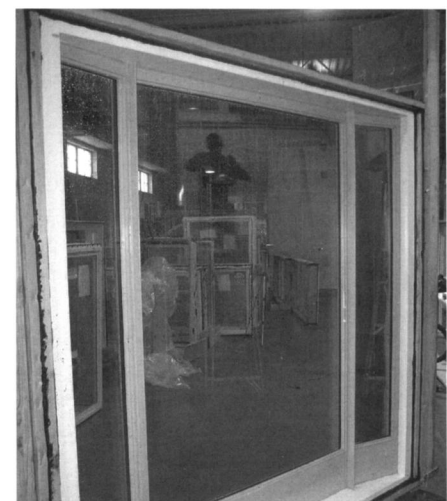
Fig. 6. Mock-up of typical fourth-floor steel-frame glass wall at the testing laboratory, photograph 2007.

innovative construction details were proposed by selected manufacturers during the bidding process (Fig. 6). Two of these manufacturers were retained by the Guggenheim to construct full-scale mock-ups representative of their systems. The mock-ups were designed to include configurations and details matching the existing conditions.

The mock-ups were subject to comparative testing at an independent testing agency. Water infiltration was tested according to ASTM E2268-04 *Standard Test Method for Water Penetration of Exterior Windows, Skylights, and Doors by Rapid Pulsed Air Pressure Difference*.<sup>11</sup> Structural properties were tested per ASTM E330 *Standard Test Method for Structural Performance of Exterior Windows, Doors, Skylights and Curtain Walls by Uniform Static Air Pressure Difference*.<sup>12</sup> Thermal performance was tested according to AAMA 1503-98, *Voluntary Test Method for Thermal Transmittance and Condensation Resistance of Windows, Doors and Glazed Wall Sections*.<sup>13</sup> Air leakage was tested according to ASTM A283 *Standard Test Method for Determining the Rate of Air Leakage Through Exterior Windows, Curtain Walls, and Doors Under Specified Pressure Differences Across the Specimen*.<sup>14</sup>

The results of the comparative testing summarized in Table 4 show that there was no significant difference between either manufacturer's system regarding air leakage, thermal transmittance, and deflection as the result of lateral forces. The water infiltration documented in one of the specimens was attributed to the lack of weep holes, an easily surmountable shortcoming.

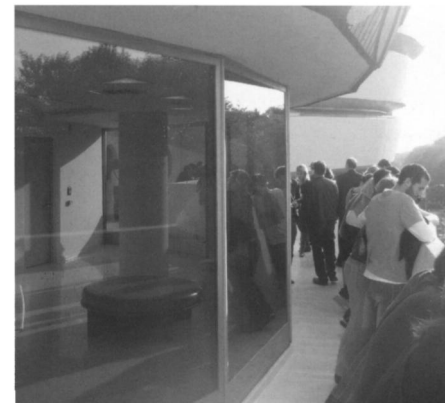
Fig. 8. Exterior view of new thermally broken steel-frame glass walls installed on the fourth floor, photograph 2009.
