# Restoring serenity: conservation of Minoru Yamasaki's North Shore Congregation Israel

Wiss, Janney, Elstner Associates, Inc., Northbrook and Chicago, IL, USA

The North Shore Congregation Israel complex was designed by modernist architect Minoru Yamasaki and completed in 1964.

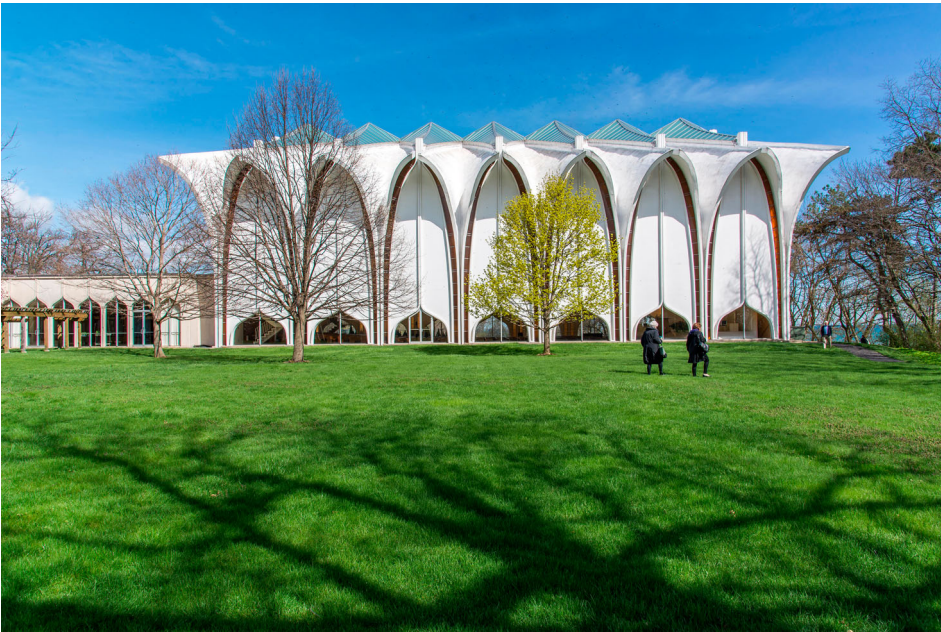
**Figure 1.** The parabolic arches of the sanctuary and the pointed arch pattern in the precast concrete panels embody the characteristics of Yamasaki's early work. (Photo courtesy of Harry J. Hunderman, FAIA).

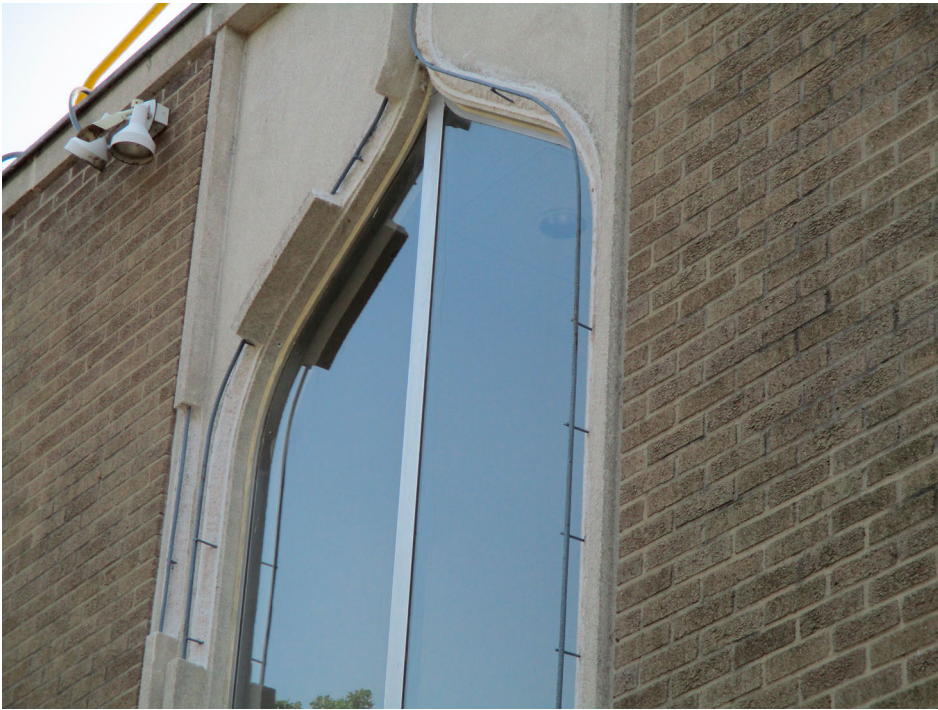
**Figure 3.** Preparation of the substrate included removal of sufficient concrete to expose all sides of the reinforcing steel, which was then abrasively cleaned and coated. (Photo courtesy of Paul Gaudette, FACI).

In addition to the installation approach, proper surface preparation is important to the long-term durability of the repairs. At North Shore Congregation Israel, preparation of the substrate included removal of all unsound concrete material and cleaning of the embedded steel to achieve bond of the repair material to the original concrete substrate. Repair details included the removal of concrete to access all sides of the corroded reinforcing steel, extending into sound historic concrete where needed. Once exposed, ongoing corrosion of the reinforcing steel was mitigated by abrasive cleaning of the reinforcing steel and application of a corrosion-inhibiting coating (Figure 3). Exposure of all sides of the reinforcing bar also allowed concrete repairs to key in and mechanically anchor to the substrate concrete.

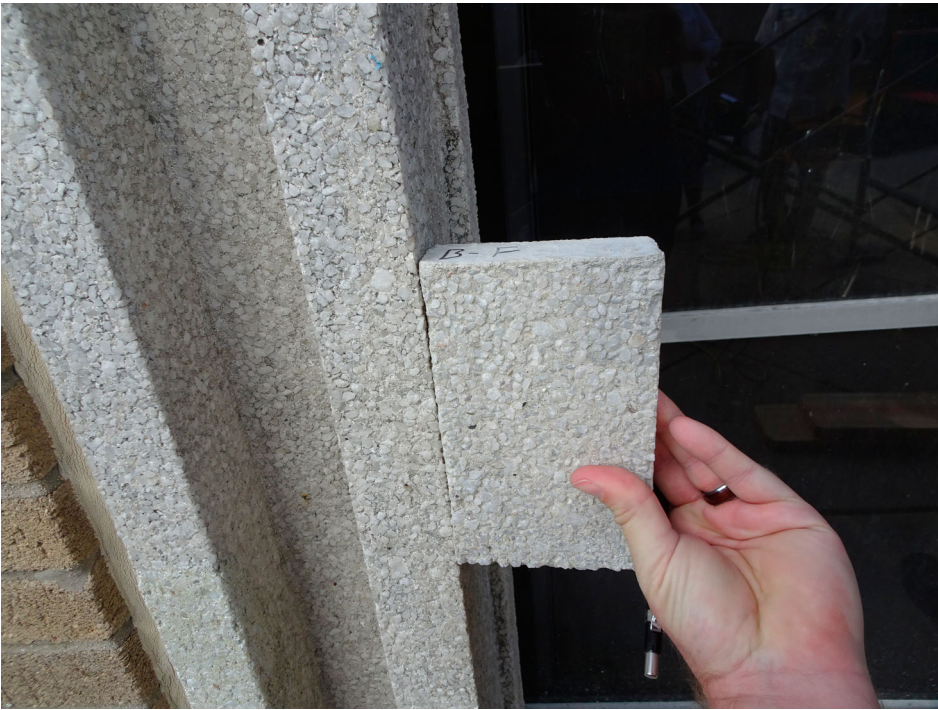
**Figure 4.** Off-building samples were fabricated to evaluate the concrete mix design and surface finish for comparison to the existing precast concrete on the building. (Photo courtesy of Mike Ford, AIA).

Once the materials in the original concrete mix design had been identified, off-building trials were performed to evaluate the concrete mix design and finishing techniques. Samples, measuring approximately 305 mm by 305 mm (12 inches by 12 inches), were fabricated by the contractor that represented a wide range of concrete mix proportions and finishing techniques (Figure 4). The off-building trials incorporated different proportions of cement, large aggregate, and sand. Various finishing techniques were also

evaluated to assist in identifying a finishing process that replicated the existing. The proportion of large white coarse aggregate to the multi-colored sands impacted the overall appearance of the concrete as did the texture of the exposed concrete finish. The off-building trials were used to refine the proportions between materials in the concrete mix design, and to develop procedure for finishing the concrete to match the appearance of the existing cleaned but weathered concrete, without resulting in unacceptable repairs on the building that would require removal.

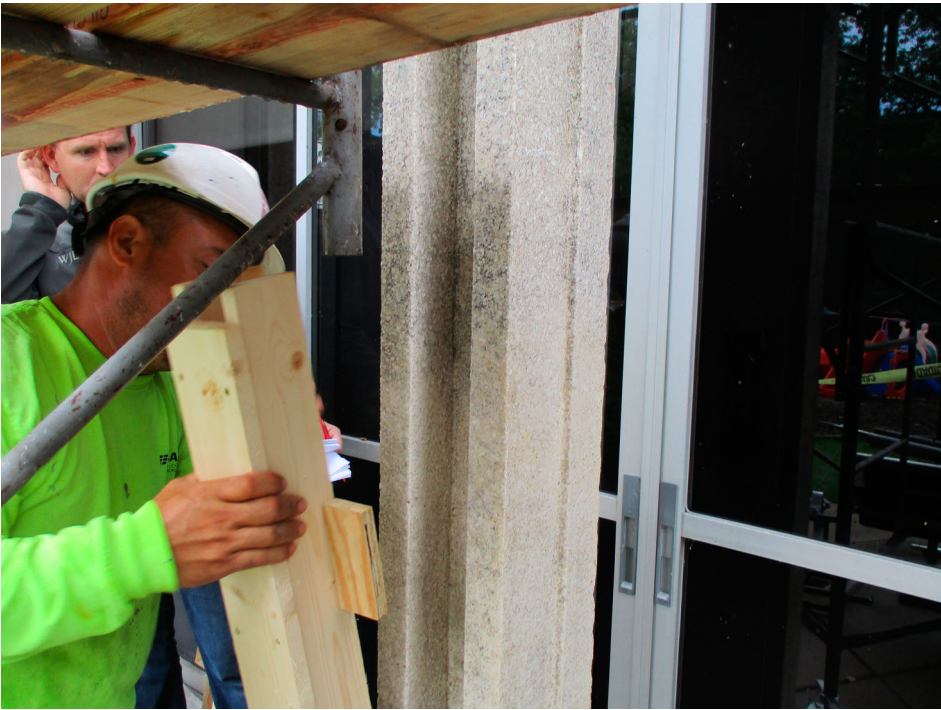
**Figure 5.** As part of the mock-ups, each step of the concrete repair process was evaluated, including the formwork and finishing techniques. (Photo courtesy of Paul Gaudette, FACI).

Once successful trials were approved, staged mock-ups were performed on the building to evaluate repairs in the field. Selected mock-up areas should represent typical distress conditions that will require repair and should be located at areas on the building that are easily accessible, to allow for execution and review of work, yet not visually apparent. At North Shore Congregation Israel, an area of spalling at the lower level on the back elevation of the building was selected. The mock-ups were performed so that every stage of the repair process could be evaluated, including cleaning of the concrete, preparation of the substrate, application of the formwork, installation of the concrete repair, and finishing of the concrete (Figure 5). The mock-ups also assist in evaluating

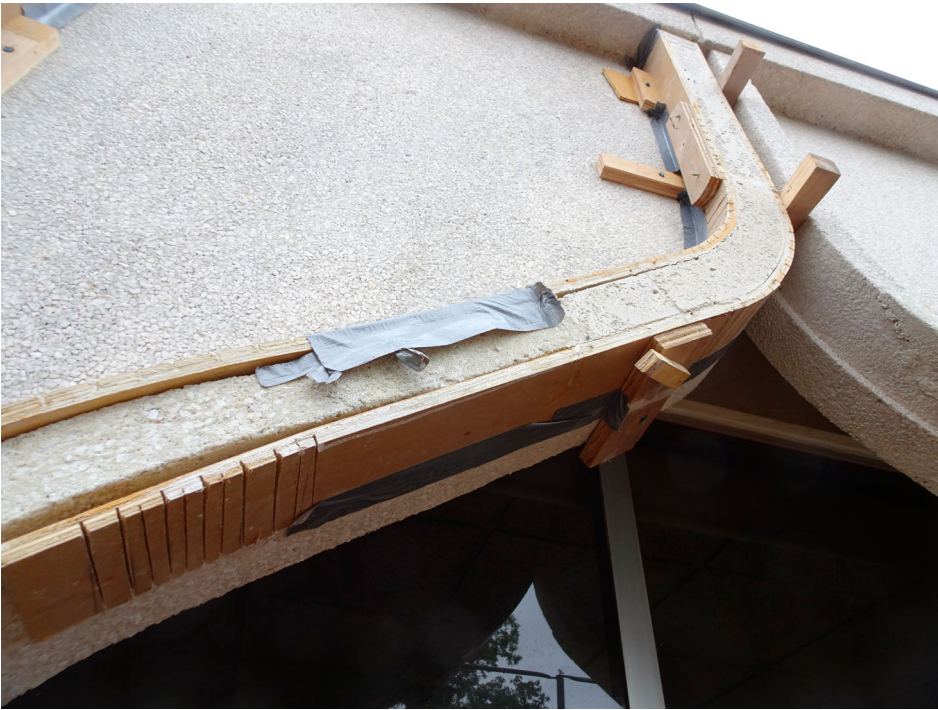
**Figure 6.** During the mock-ups, a process was developed for shaping the formwork around the curved contours of the concrete. (Photo courtesy of Mike Ford, AIA).

the constructability of repairs and challenges that will be faced in repair implementation. The curved forms of the precast concrete panels at North Shore Congregation Israel presented a challenge in terms of the installation of formwork. The contractor created plywood forms that were scored on the backside, bent in the field to match the contours of the repair area, and secured in place with clamps (Figure 6). There were also challenges with developing a consistent and constructible procedure for finishing the concrete. Through the process of trials and mock-ups, a system was developed where a retarder was applied to the formwork prior to installation of the concrete repair mix. After approximately 24 hours of concrete cure, the forms were removed and the concrete was hand brushed to expose the aggregate to a depth that resembled the existing concrete adjacent to the repair area. Mock-ups allowed the project team to work through complicated conditions and develop a repair approach prior to implementing repairs throughout the whole building (Figure 7).

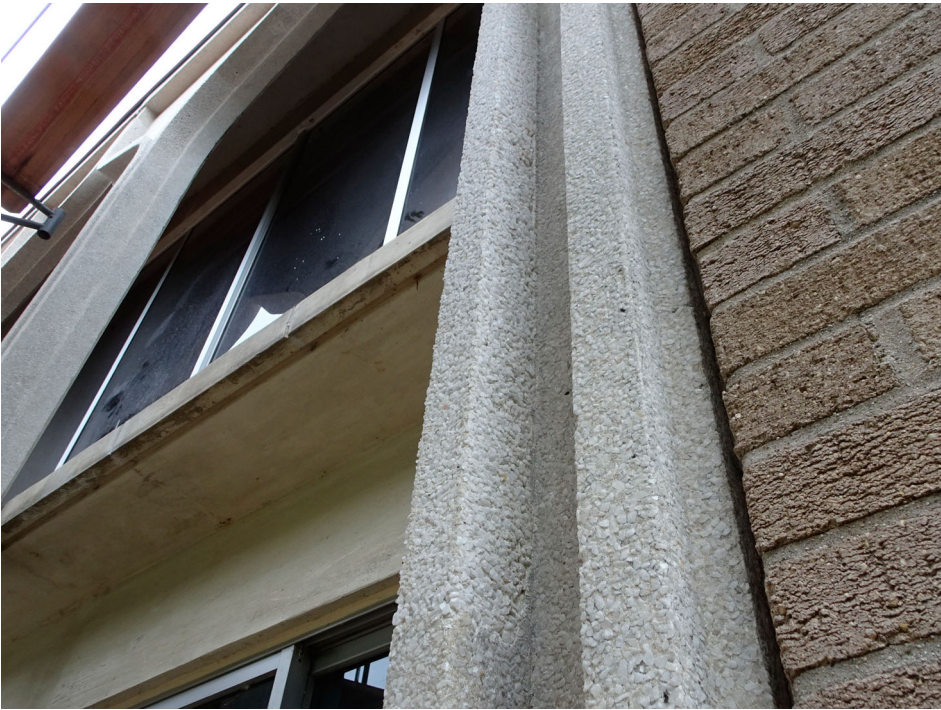
**Figure 7.** An example of the completed repairs at a window perimeter, showing the successful match of the repair to the original exposed aggregate precast concrete. (Photo courtesy of Mike Ford, AIA).
