# Fallingwater Part 1: Materials-Conservation Efforts at Frank Lloyd Wright's Masterpiece

NORMAN WEISS, PAMELA JEROME, and STEPHEN GOTTLIEB

**A 13-year-long investigation of deterioration mechanisms, along with prototype treatments, has yielded a better understanding of the nonstructural pathology of materials deterioration at a twentieth-century architectural icon.**

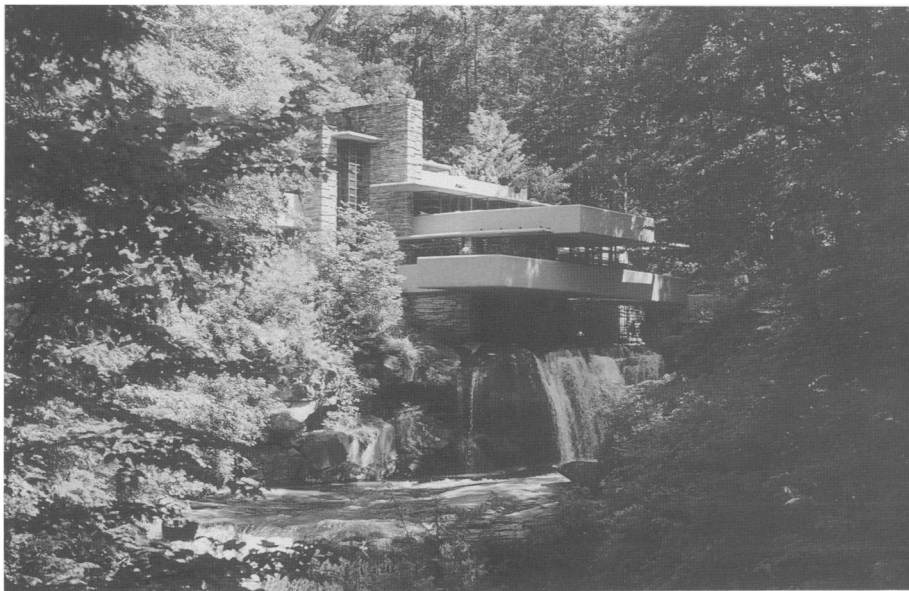
Fig. 1. Fallingwater, which rises dramatically among its densely foliated surroundings and is perched over a waterfall, is the embodiment of Frank Lloyd Wright's organic architecture. This continuously damp environment is largely responsible for materials deterioration. Photograph by WASA. All photographs courtesy of the Western Pennsylvania Conservancy.

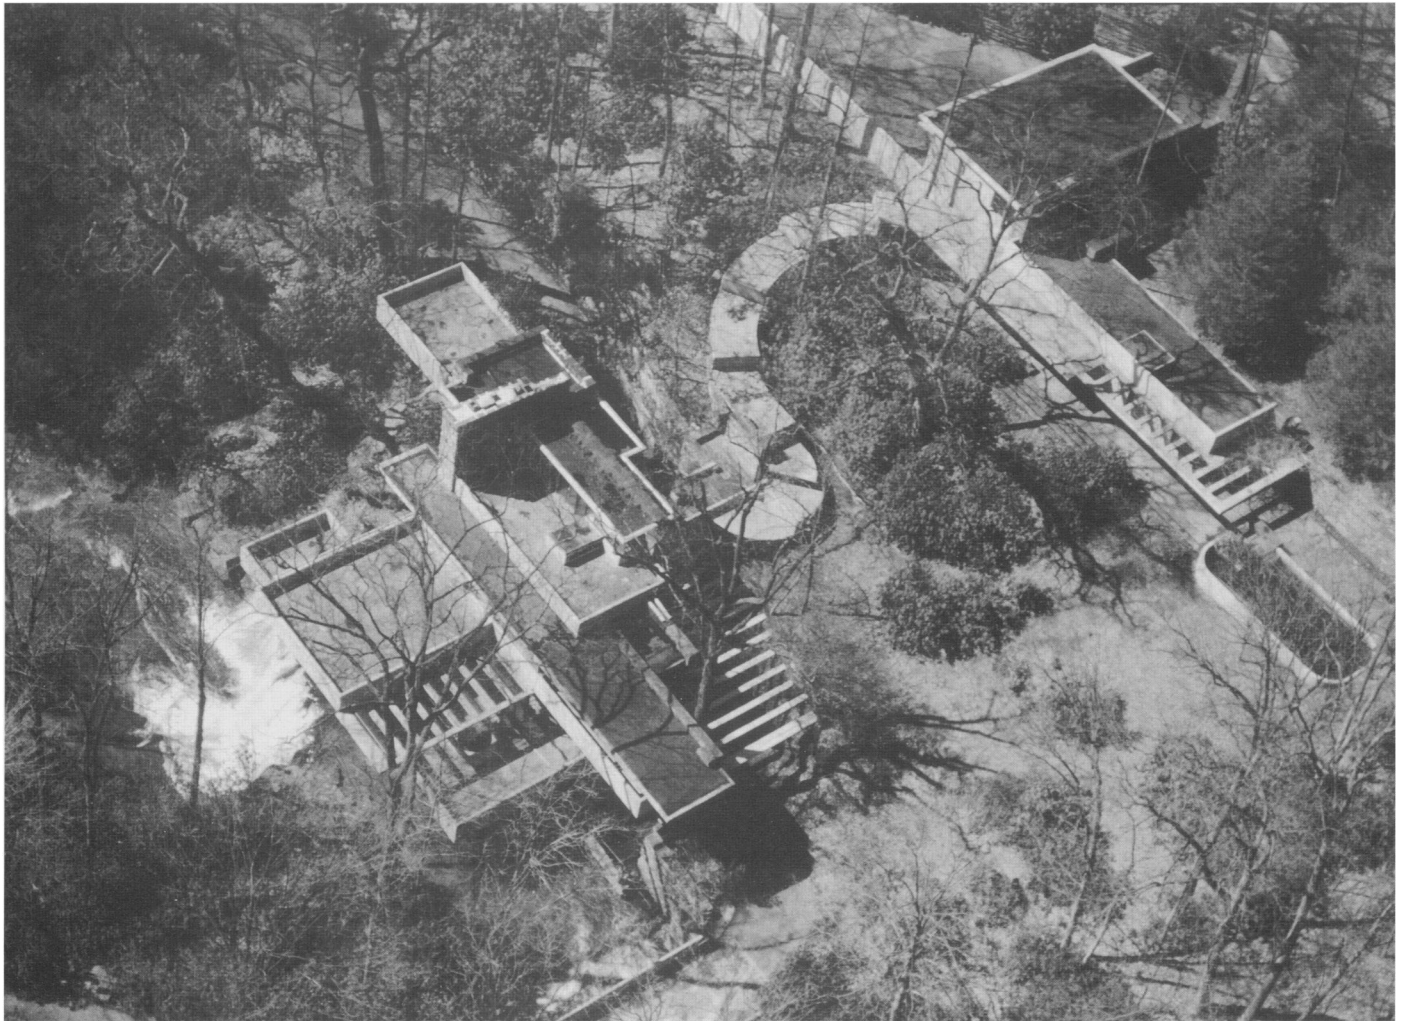
Fig. 2. Aerial view of Fallingwater's main house, with the guest house visible in the upper-right-hand corner. More than half of the approximately 7,000 total square feet is terrace area. Photograph by Paul Wiegman.

Fallingwater is a large weekend residential complex with approximately 7,000 total square feet, of which almost half is terrace area (Fig. 2). The main house, articulated by massive terraces at each level, stands three stories tall. Additionally, there is a two-story guest house with servants' quarters and carport further uphill. In style, this modernist building acknowledges its De Stijl and Bauhaus predecessors, as well as Richard Neutra's Lovell Heath House of 1929.<sup>8</sup>

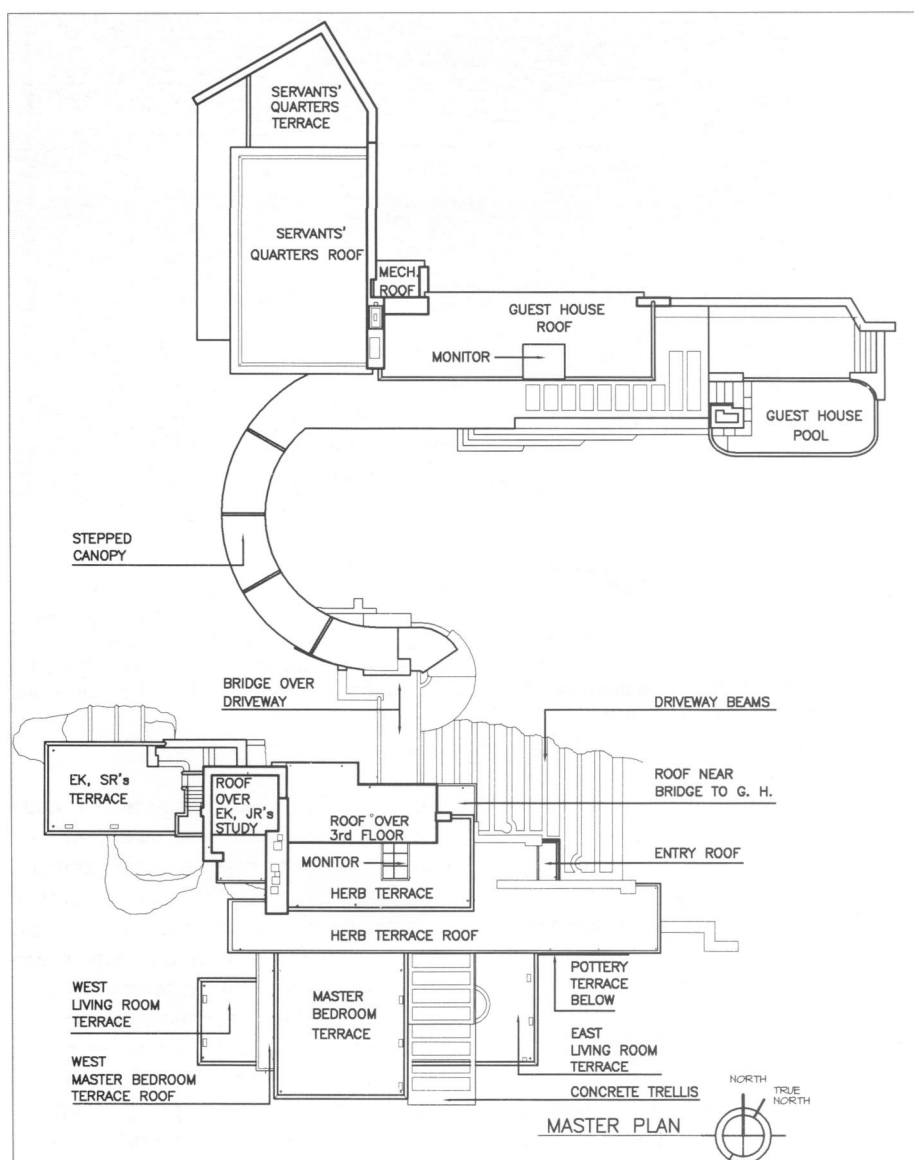
Fig. 3. Plan of Fallingwater. Drawing by WASA. All drawings, except as noted, used courtesy of the Western Pennsylvania Conservancy.

Fallingwater is shaped like a pin-wheel in plan, with extensive terrace arms projecting outward (Fig. 3). Exposure of horizontal surfaces to the weather is much greater than for a more traditional house of the 1930s. Penetration of rain and melting snow, associated with waterproofing/roofing systems failures and the lack of through-wall flashing, is a continuing problem in many locations.
