# Fallingwater Part 2: Materials-Conservation Efforts at Frank Lloyd Wright's Masterpiece

PAMELA JEROME, NORMAN WEISS, and HAZEL EPHRON

**Following a 13-year study of building behavior and conservation techniques, Fallingwater's challenging five-year-long restoration is nearing completion.**

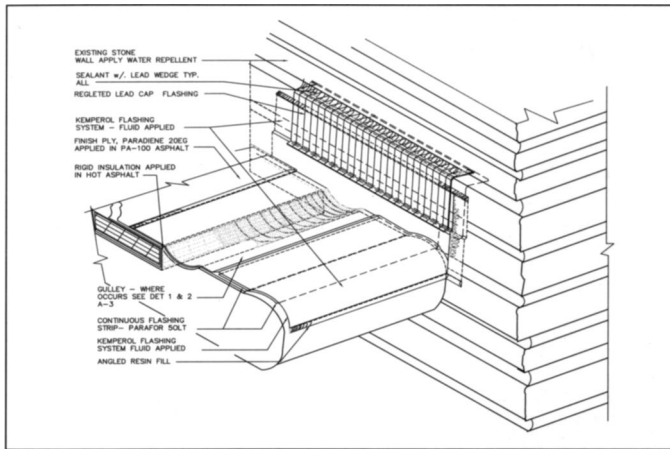
Fig. 3. Axonometric detail of modified-bitumen-roofing system, showing the base flashing terminating on the roof roll and new lead cap flashing inserted into a reglet.

was used, thus solving the difficult issue of how to terminate the roofing on the roof rolls (Fig. 3).<sup>11</sup> The liquid-membrane base flashing was applied to the midpoint of the roof roll and painted with an acrylic elastomeric paint (PPG Pitt-Flex) to match the stuccoed surfaces, creating a virtually invisible termination (Fig. 4). (In the previous system, the EPDM membranes had been secured with termination bars fastened with impact-expansion anchors, which failed.) Where base flashing abutted irregular stone walls, a mix of one part Type II gray portland cement to two and one-half parts sand was used to parge the substrate smooth.

Siplast's typical base-flashing system — foil-faced in either copper or stainless steel — was considered aesthetically inappropriate for Fallingwater. Instead, in collaboration with Kemper System, a polyester fleece-reinforced, liquid-membrane base flashing (Kemperol V210)

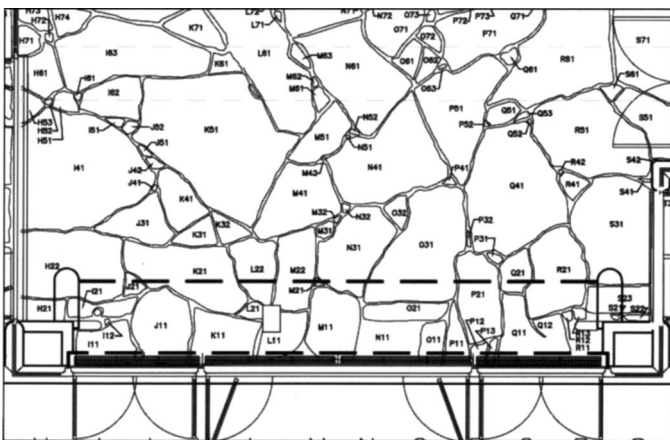
Waterproofing of the terraces required very accurate stone-by-stone scale drawings of the flagstones to ensure that the stones were returned to their original positions. Stone-by-stone drawings were also generated for the living-room and the covered-bridge floors, since they were both going to be lifted (Fig. 5).<sup>12</sup> The bridge floor required waterproofing because a natural stream that trickles over the boulder at the north elevation is evacuated through a drain in the slab. In the case of the living room, however, nearly the entire room was dismantled (including built-in furniture) to permit access to the top side of the cantilever beams so that cracks could be grouted prior to post-tension-

Fig. 5. Stone-by-stone drawings were traced by hand from photo mosaics. The tracings were digitized and then inserted to scale with a grid into the construction drawings. These provided a guide for reinstallation of each flagstone floor or terrace scheduled to be lifted. This detail from a drawing depicts the south end of the living room.
